tmmob  
mimarlar  
odası

**6 FEBRUARY 2023**  
**EARTHQUAKES DETECTION**  
**AND EVALUATION REPORT**

**23 FEBRUARY 2023**

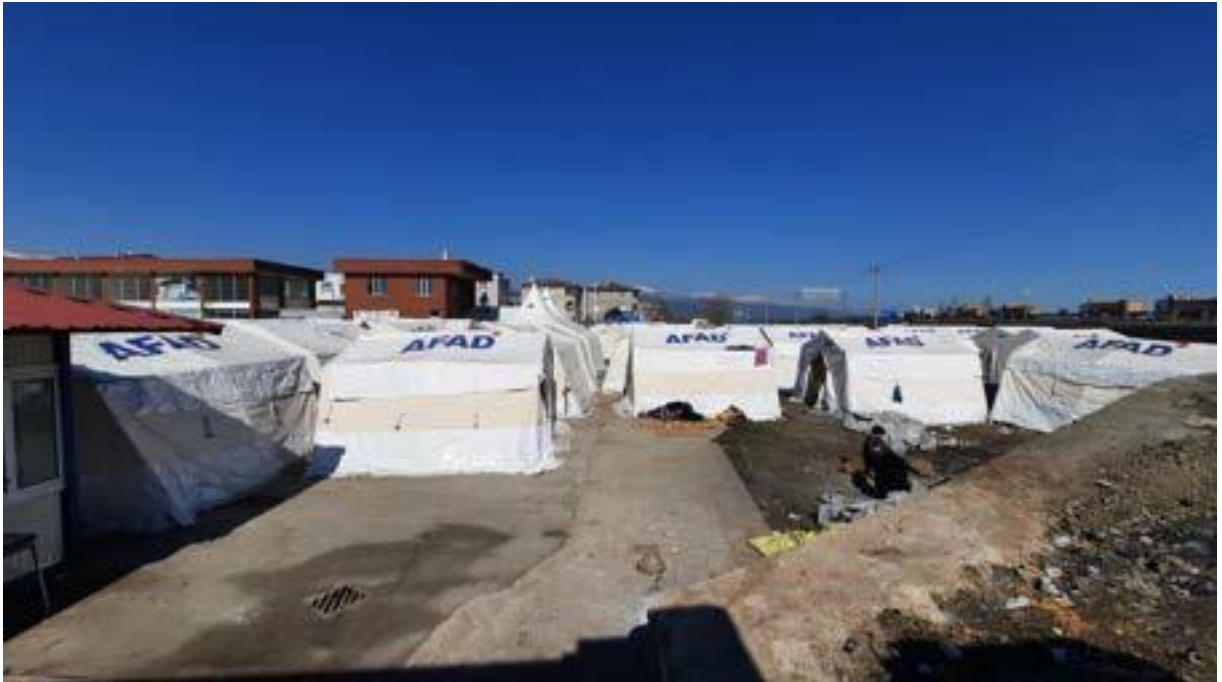
Islahiye - Bus Terminal tent compound

It was observed that a tent settlement was established in front of the bus terminal in Islahiye. However, it was observed that fire, epidemics and security problems may occur due to the irregular and close proximity of the tents.

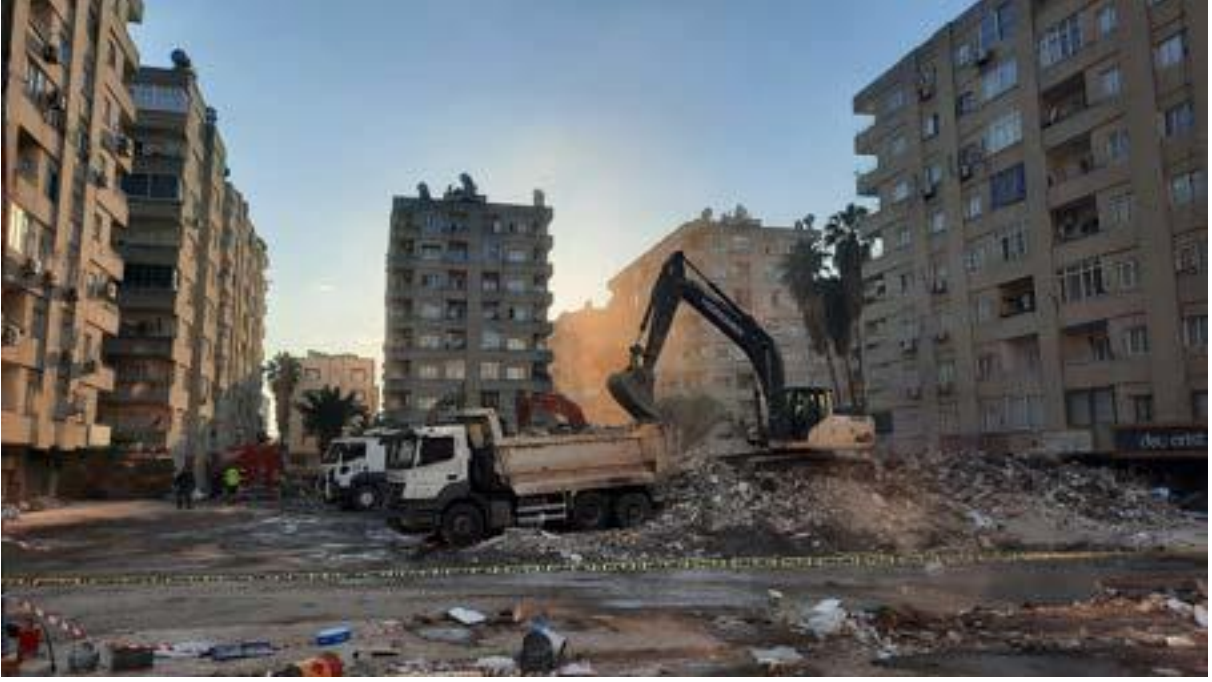
Metin Tamer Housing Estate consisting of 12 blocks built in the 1990s in the city was heavily damaged and some blocks were demolished.

Osmaniye - Metin Tamer Site after earthquake

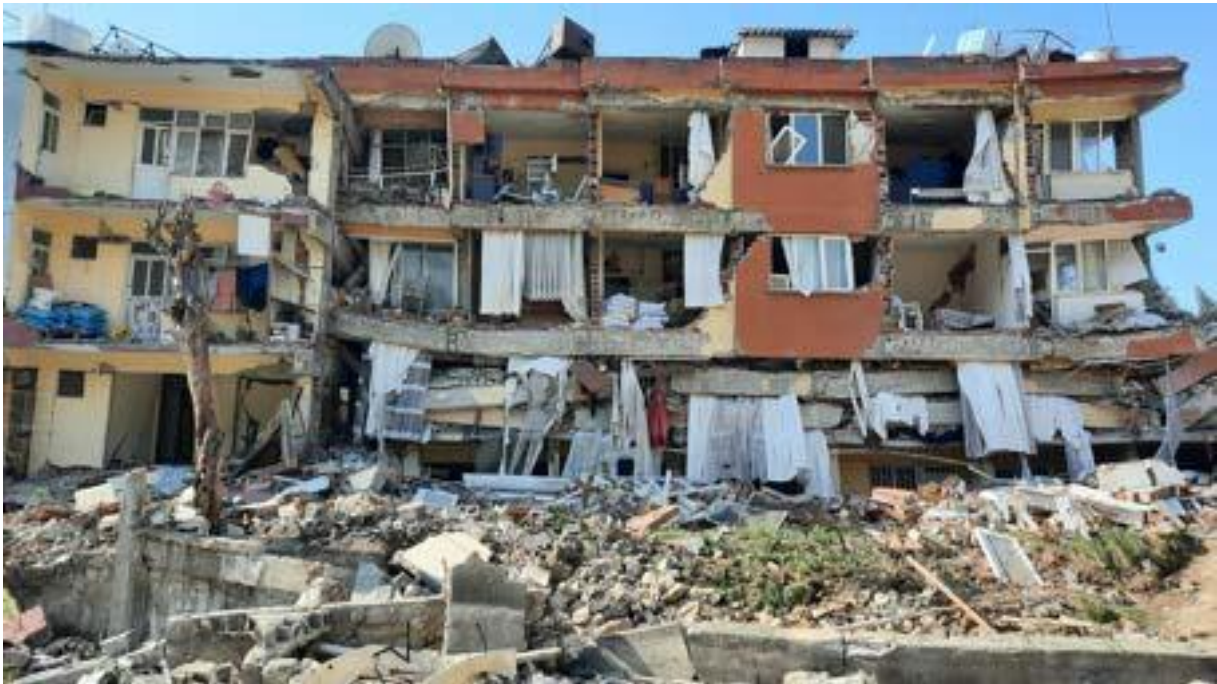
In Defne district and Antakya, it was observed that low-rise buildings and small industrial estates that did not receive qualified architectural engineering services were severely damaged or collapsed. However, extensive damage was also observed in buildings constructed after the recent updates of the Turkish Building Earthquake Code in 2007 and 2018. In most of the buildings, it was observed that residential and commercial functions were used together and the soft floor effect was intense on the floors where commercial activities were carried out.

Hatay - heavily damaged and demolished buildings in the city centre

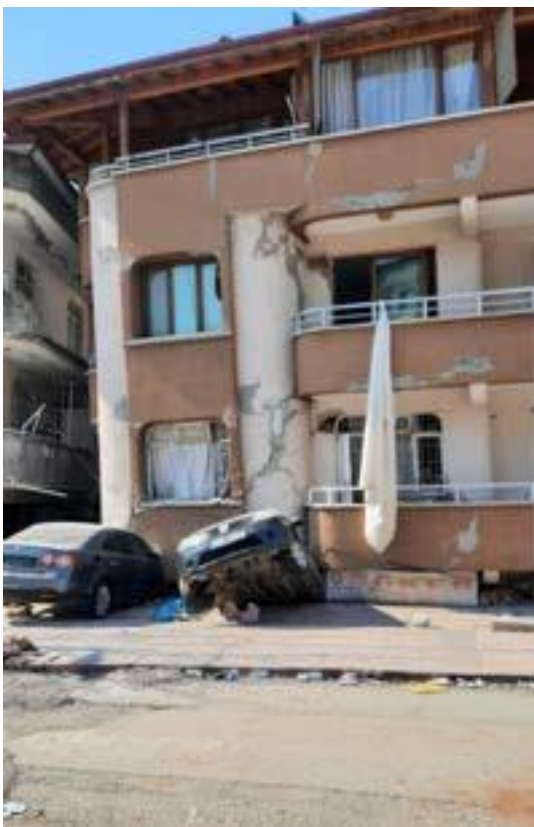
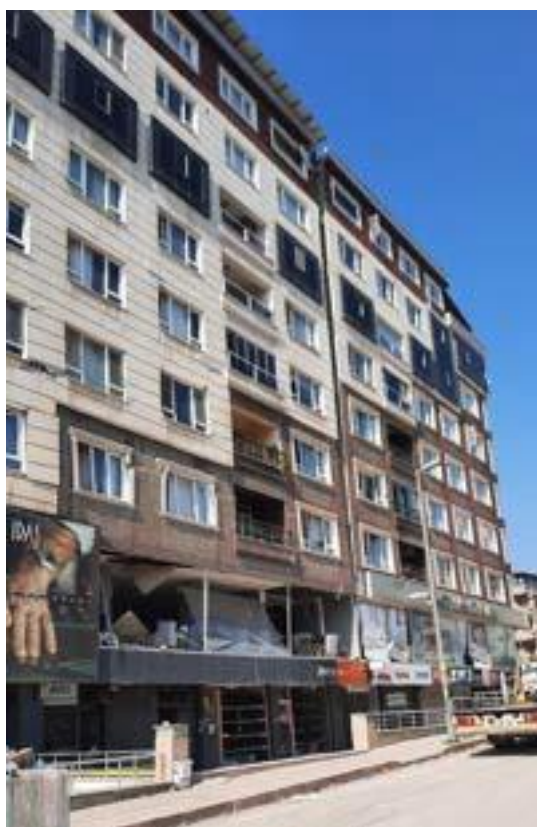
Hatay - heavily damaged and demolished buildings in the city centre

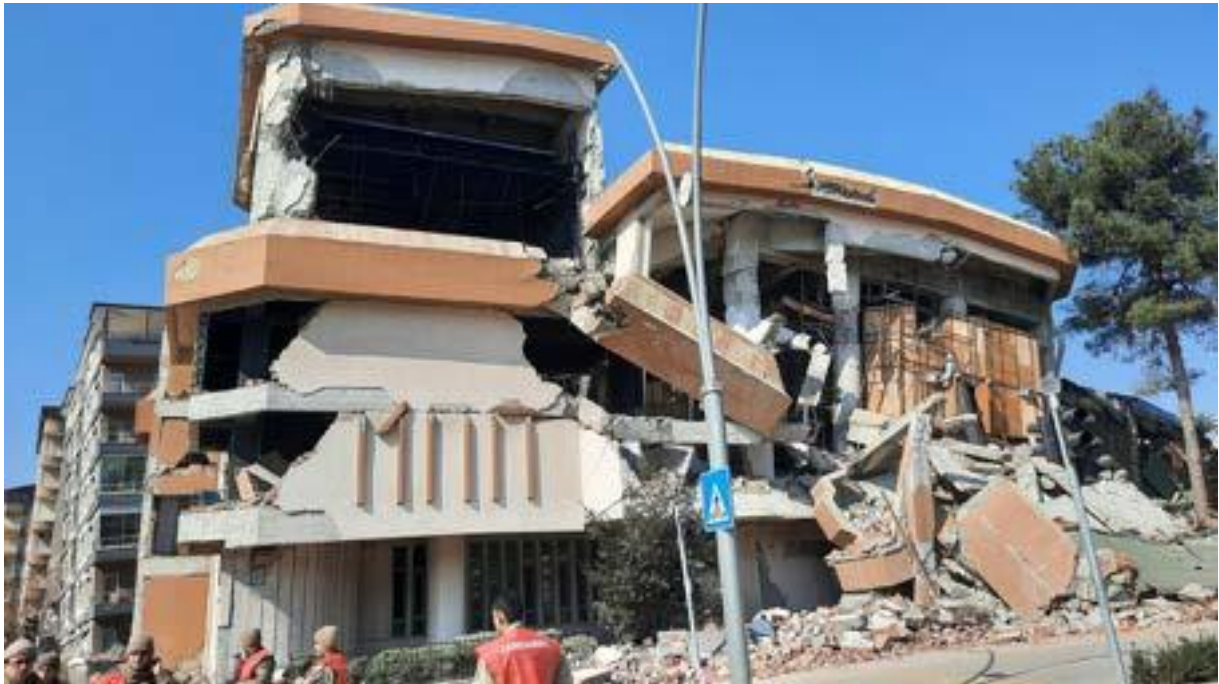
Damage to Hatay Cultural Centre after the earthquakes of 6 February 2023

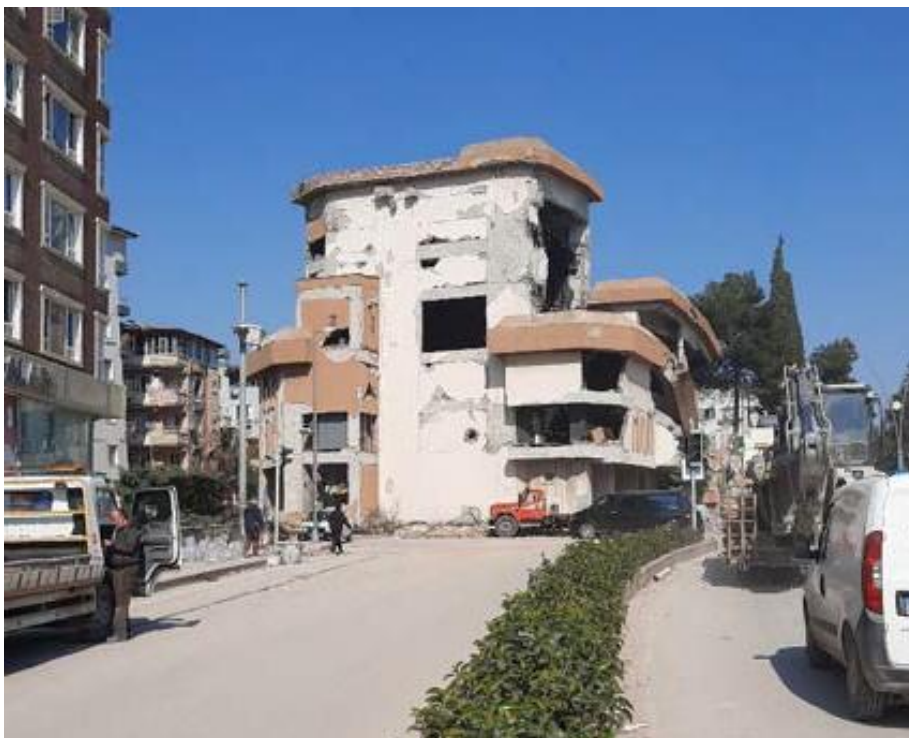
Damage to Hatay Cultural Centre after the earthquakes of 6 February 2023

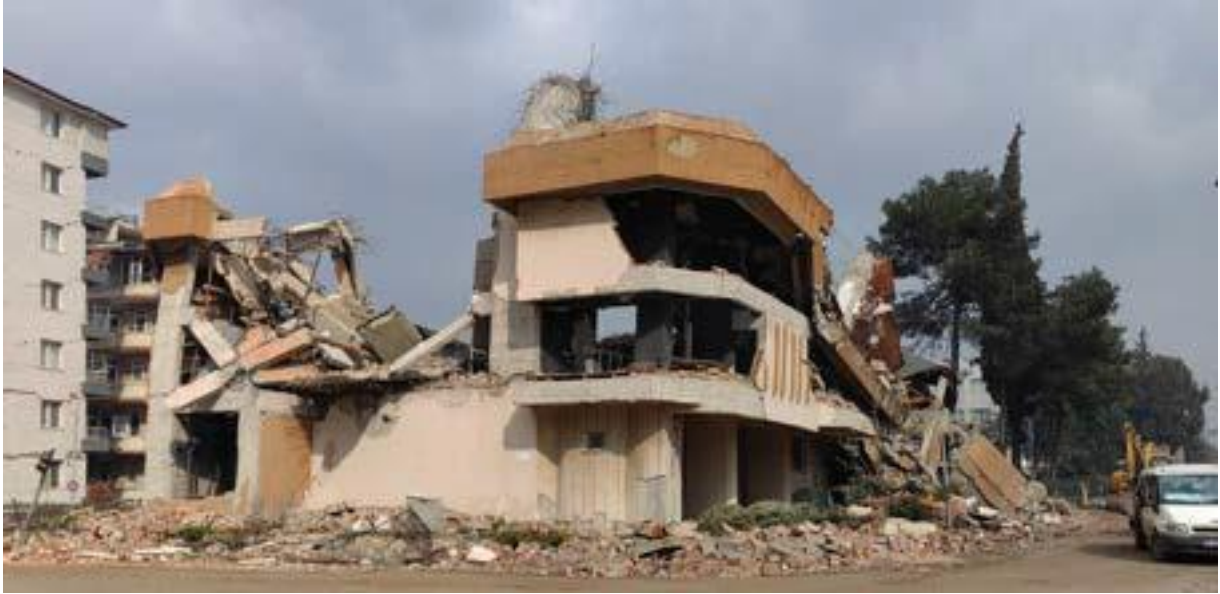
Damage to Hatay Cultural Centre after the earthquake of 20 February 2023

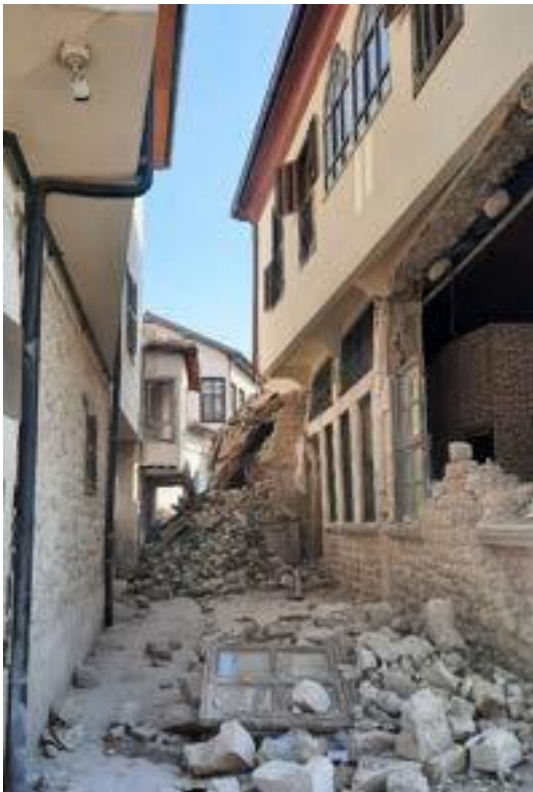
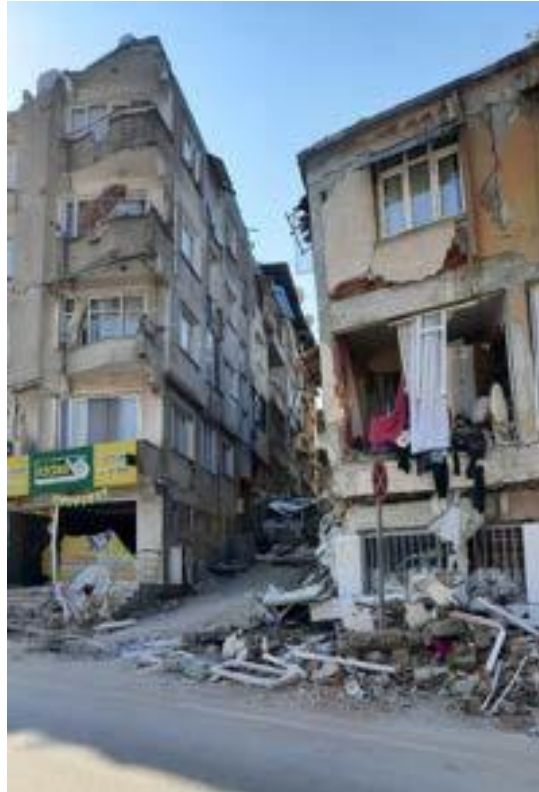
Damage to Hatay city centre after the earthquakes of 6 February 2023

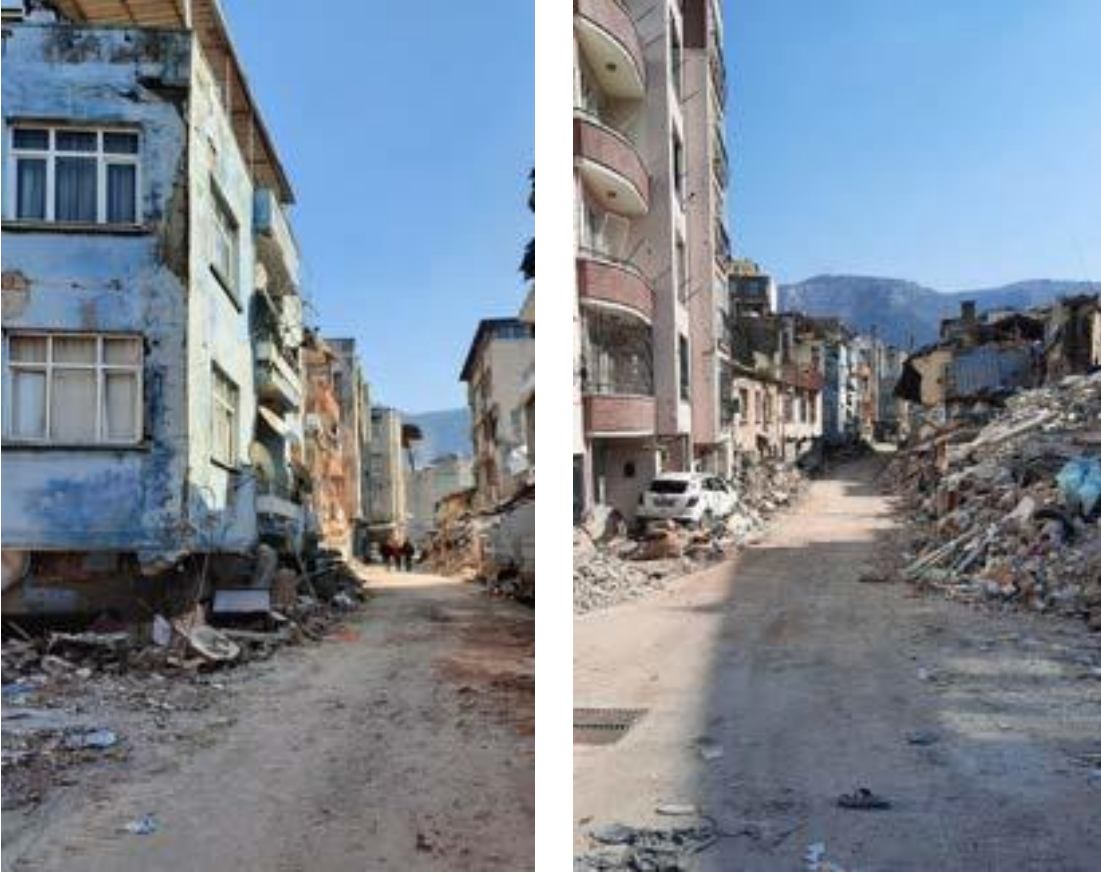
Damage to Hatay city centre after the earthquakes of 6 February 2023

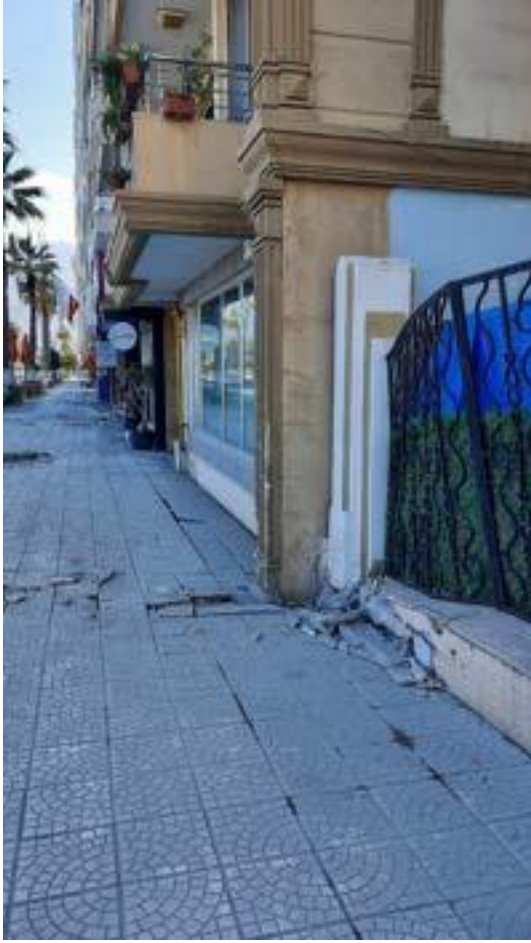
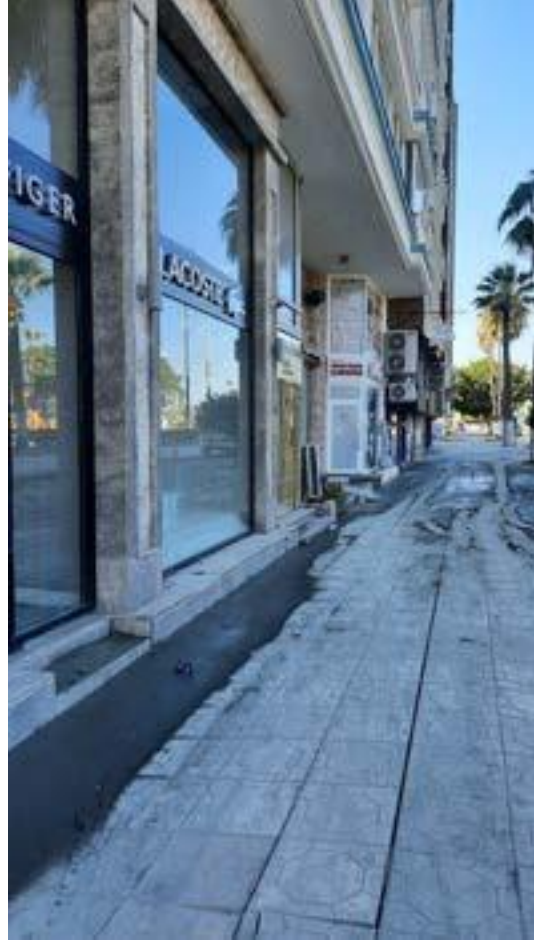
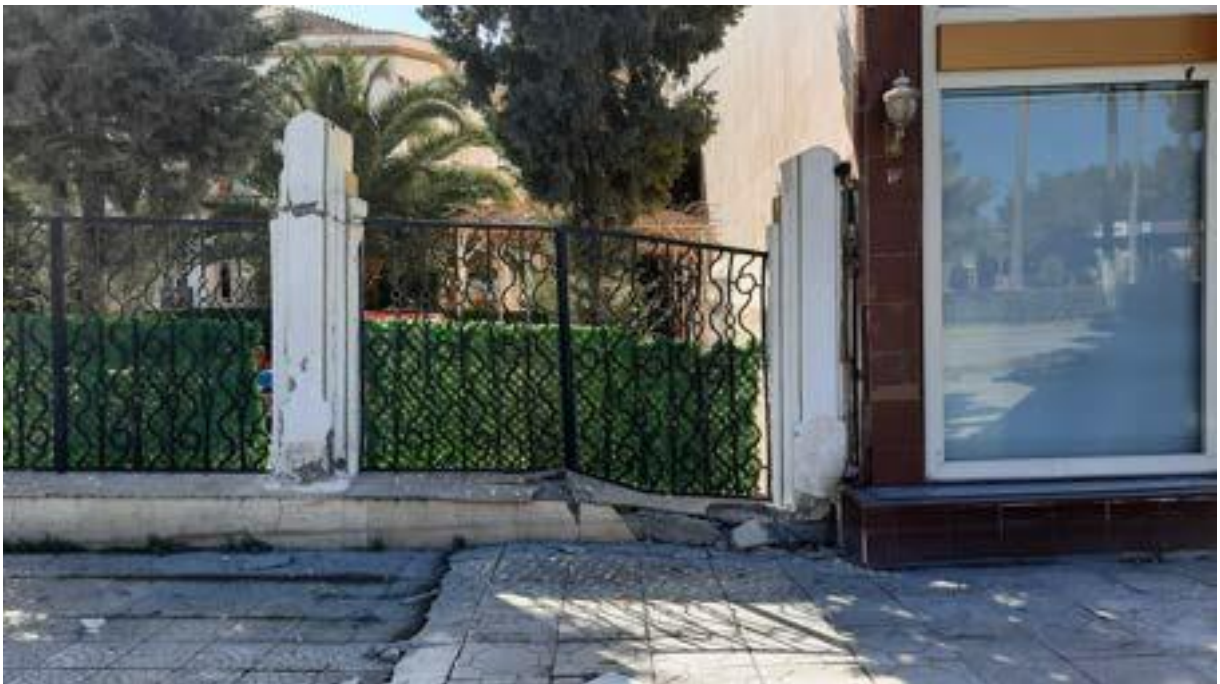
Iskenderun Cengiz Topel Caddesi

In Iskenderun city centre, liquefaction, subsidence and heaving were observed on Cengiz Topel Street and Atatürk Boulevard on the coastline. It was observed that the buildings on the boulevard collapsed to the ground by 1 metre. On the second day of the earthquake, the sea level rose and the buildings and roads on the coast were under water.

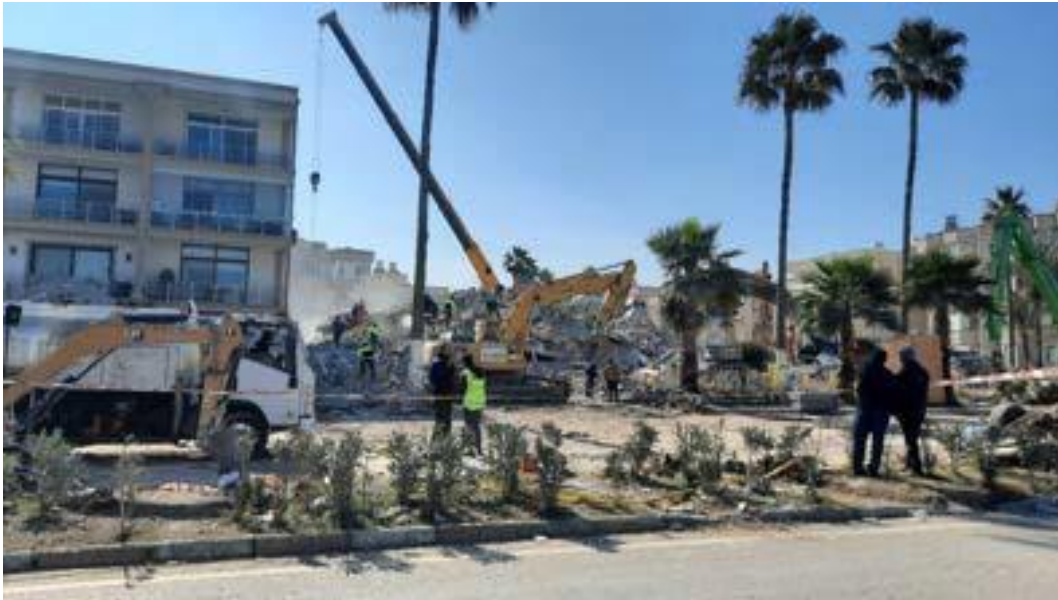
Iskenderun - Eda Apartment

The 8-storey Eda Apartment Building on the beach was demolished as a result of the construction of 4 more floors above the 4 floors permitted by the zoning rules. In the other two demolished buildings on the beach, it was reported that there were 4 illegal storeys over 4 storeys.

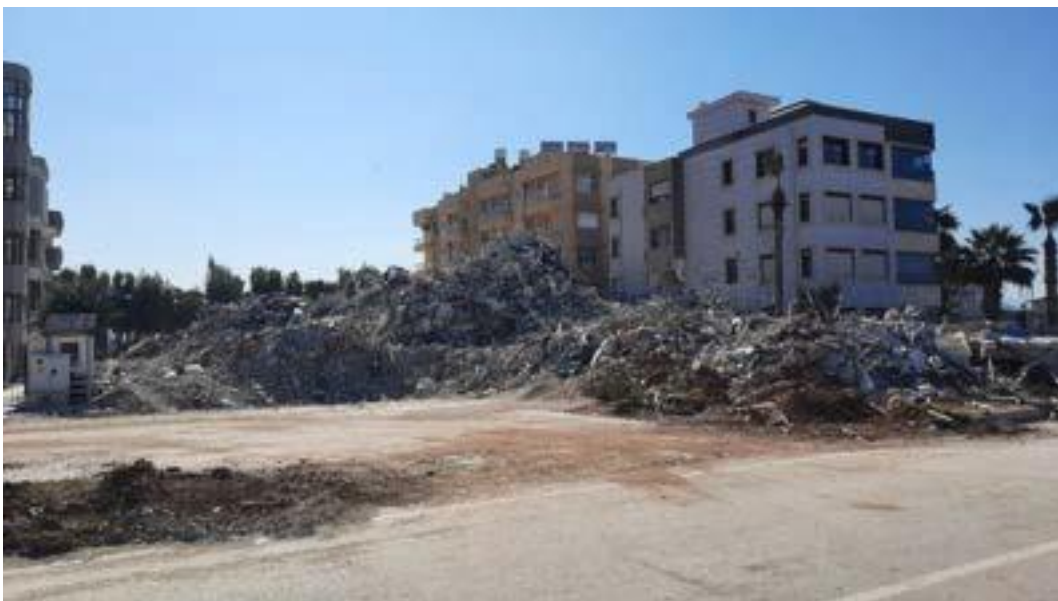
Iskenderun - Multi-storey buildings demolished on the coastal belt

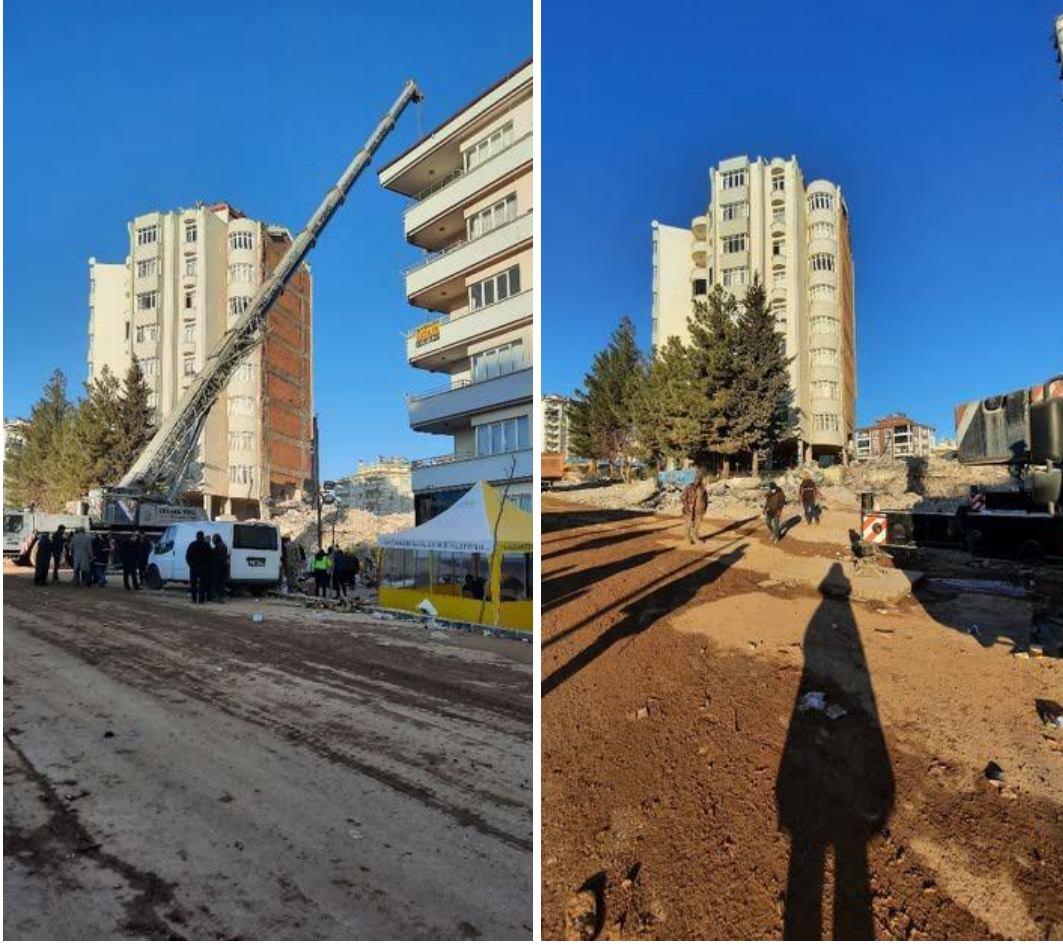
Gaziantep - Ayşe-Mehmet Polat Sitesi

In the 6-block Ayşe-Mehmet Polat Complex located on Naci Topçuoğlu Boulevard, 4 blocks collapsed completely. It was observed that the buildings with adjoining building layout had different floor heights on the ground and ground floors, and the reinforcement and concrete quality were low.

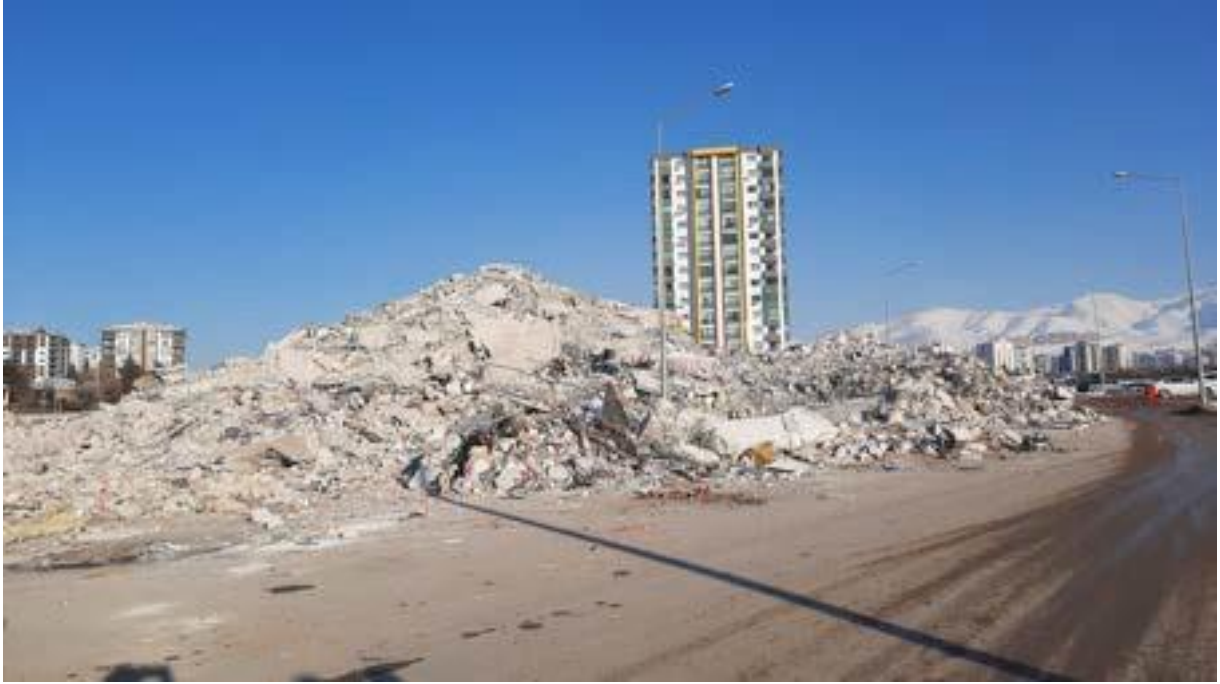
Malatya Bostanbasi Neighbourhood

It has been observed that most of the buildings in Yakınca and Bostanbaşı neighbourhoods on the city periphery are heavily damaged or demolished. It is known that the heavily damaged or demolished buildings were completed 3-5 years ago; there are some demolished buildings that were completed only 6 months ago.

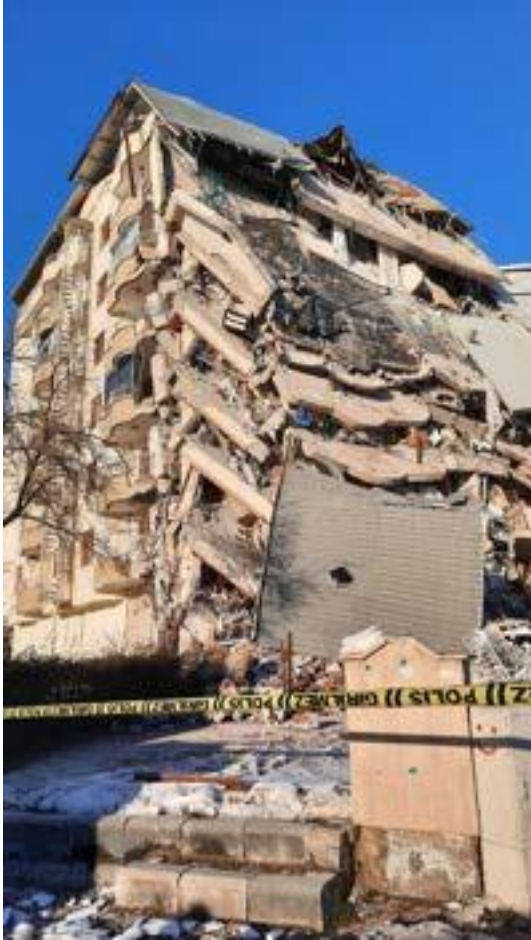
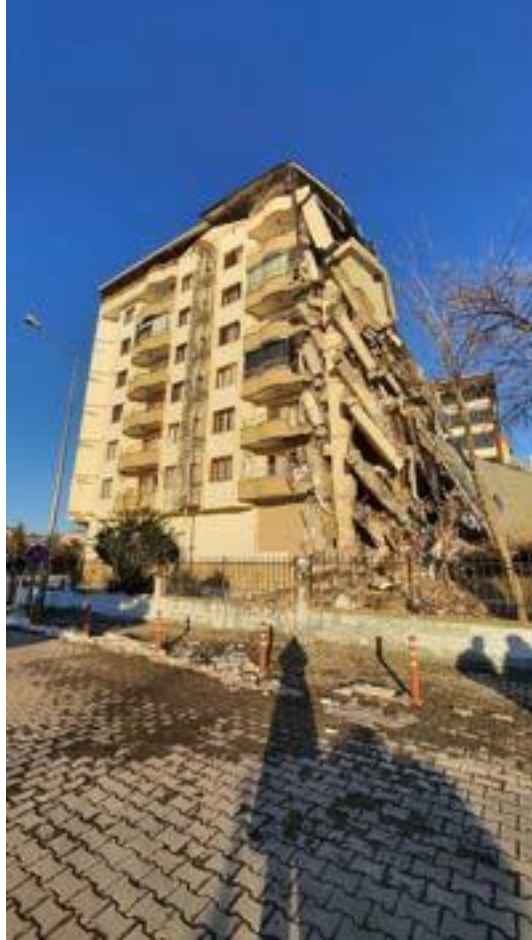
Malatya Bostanbasi Neighbourhood

In most of the damaged or demolished high-rise buildings in the city, it was observed that the storey height was given more (5.5 m) for commercial activities on the ground floors, which caused short columns and soft floor effect in the buildings. It was observed that the reinforcements were not fixed in the damaged buildings and most of the roofs were slipped.

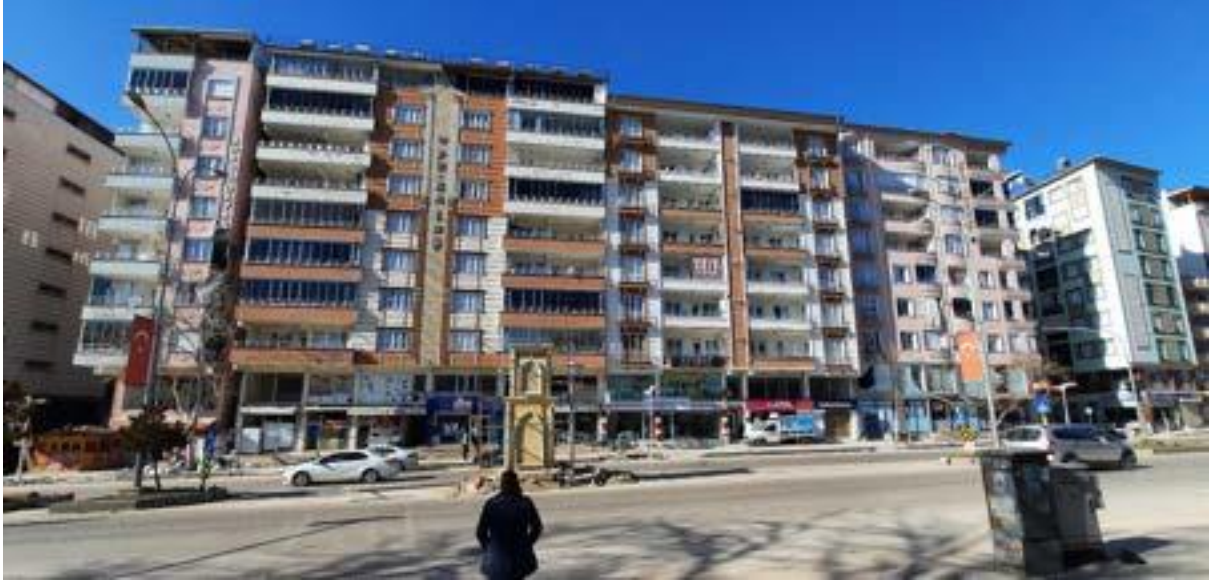
Pazarlık city centre

It has been observed that the storey heights of these buildings are higher due to the commercial activities on the ground-floor floors, which creates short columns and soft storey effect in the buildings.

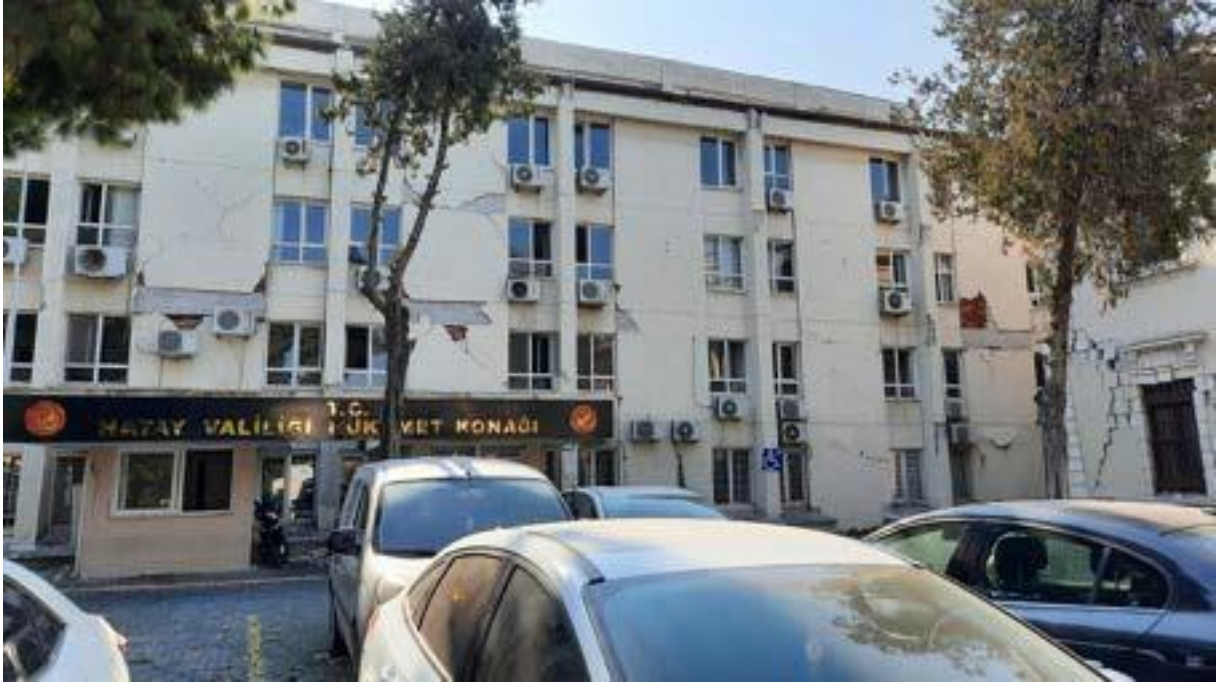
Hatay Governorship Government Office

It was observed that public buildings in the city were also heavily damaged, and the registered building of the Hatay Governorship as well as the reinforced concrete building of the Government Office were heavily damaged. It was learnt that an inspection was conducted in 2012 to determine whether the reinforced concrete building posed a risk.

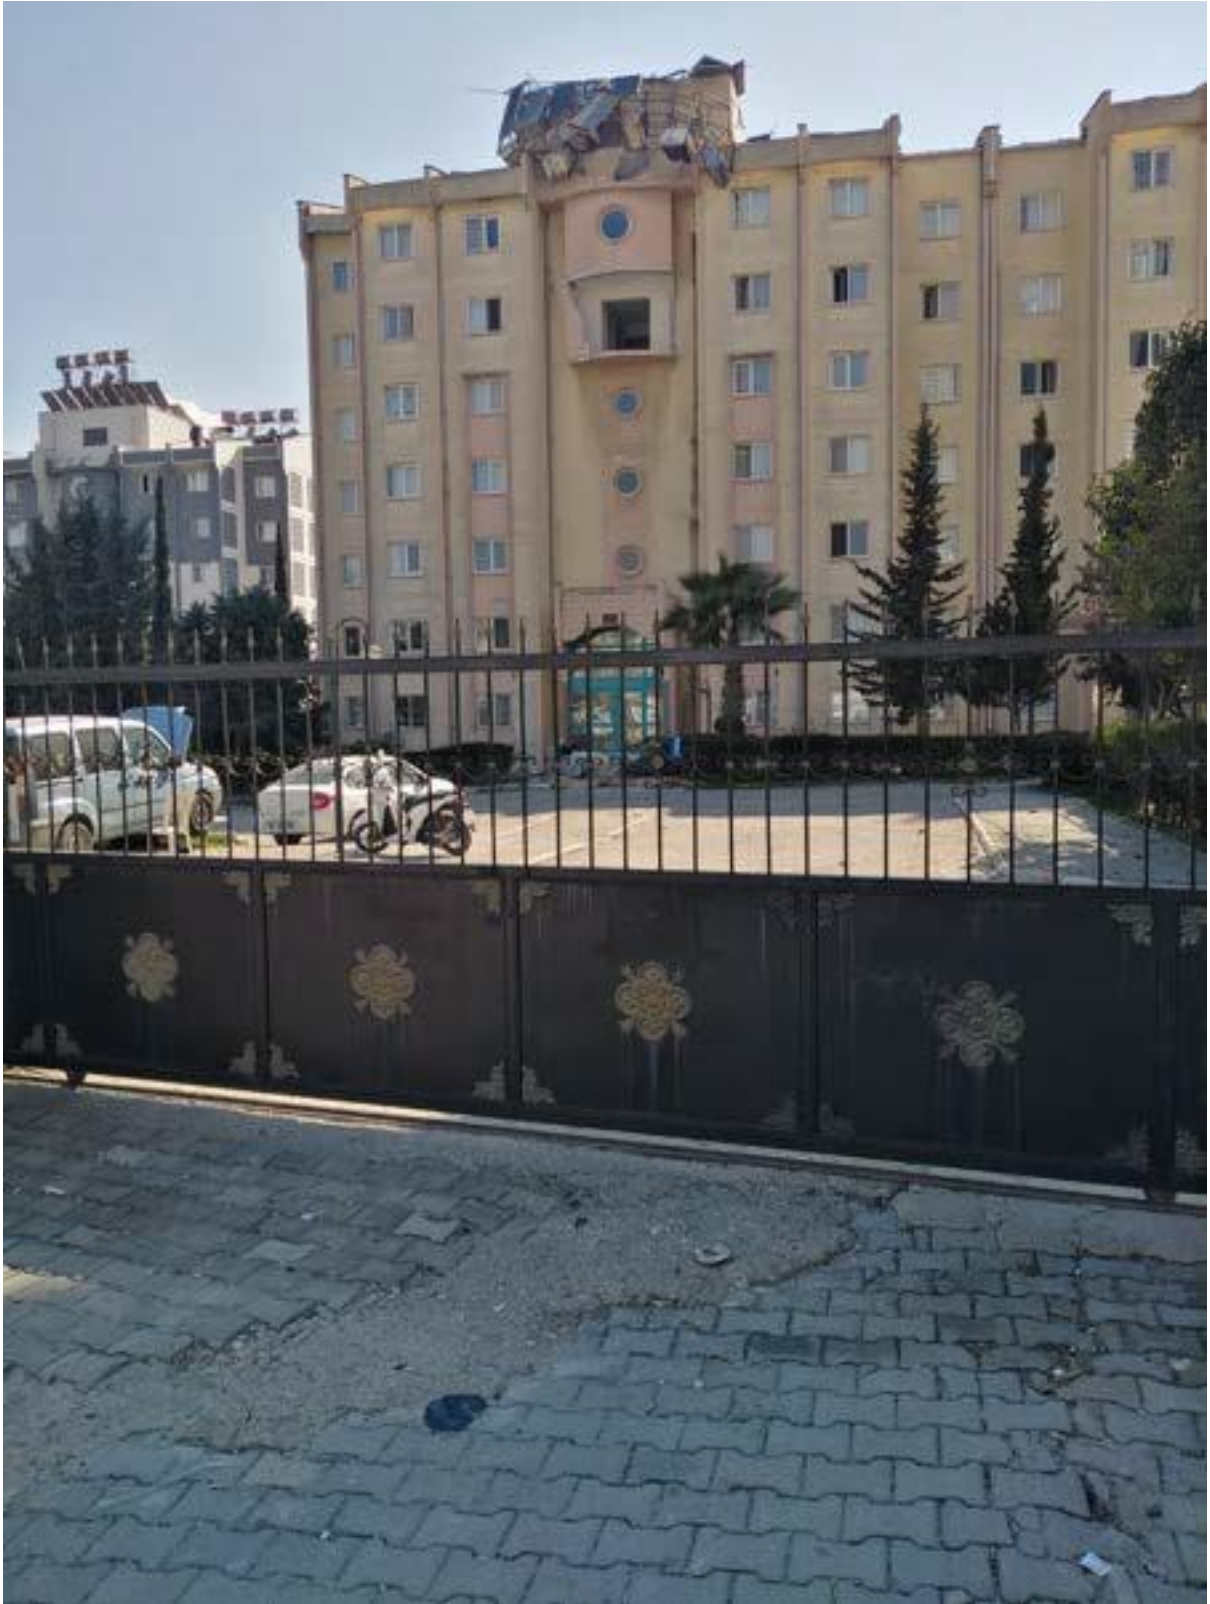
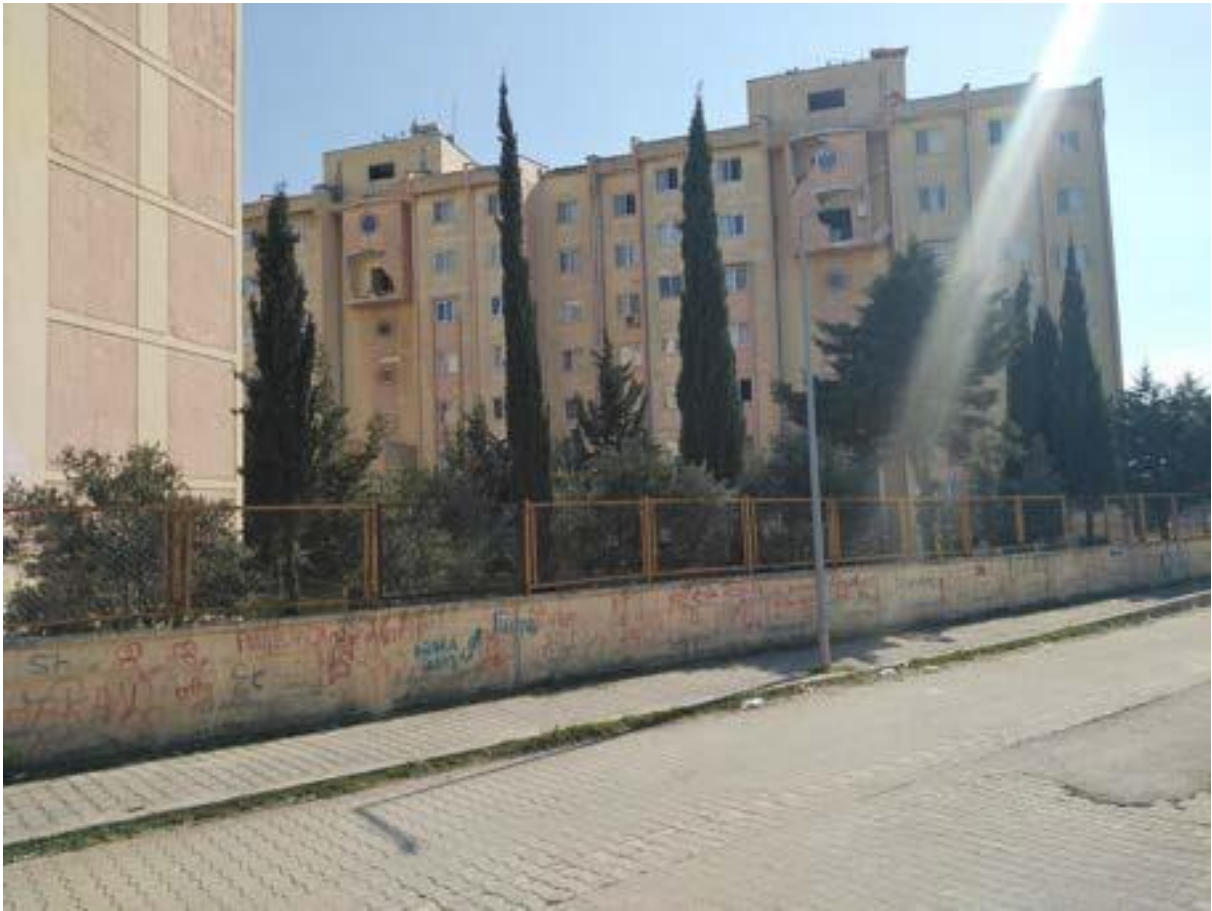
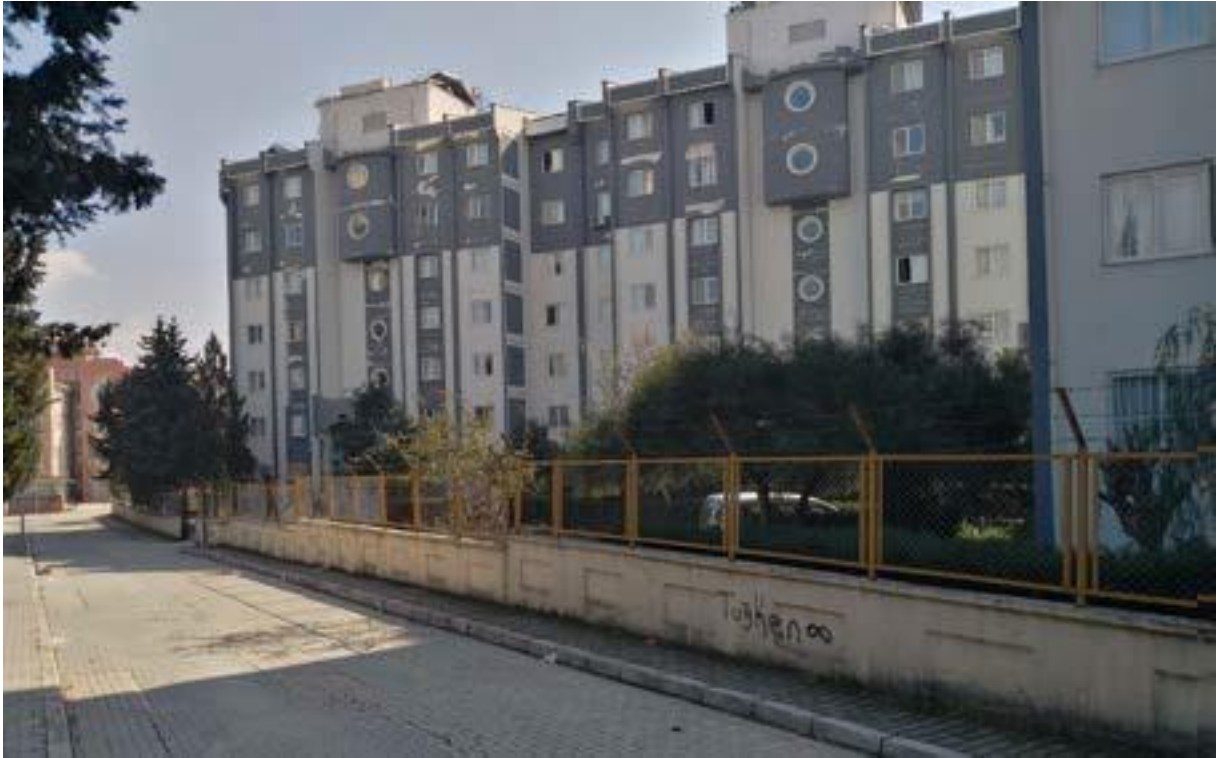
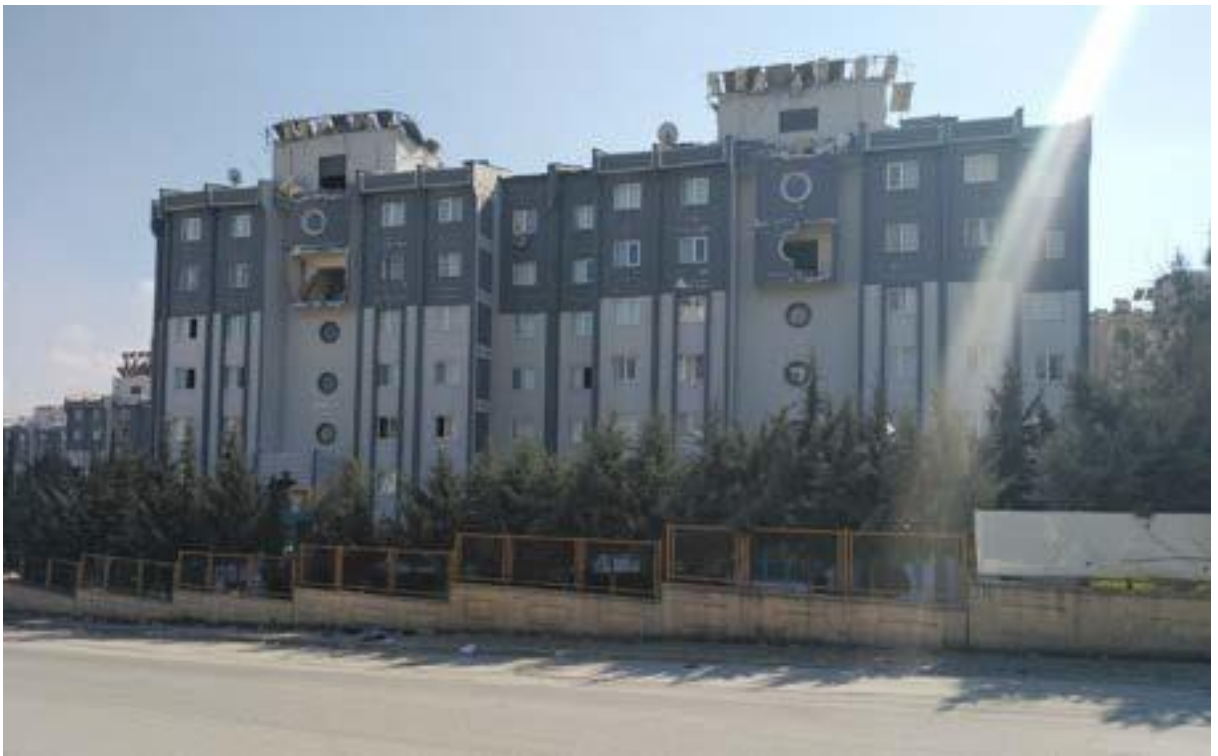
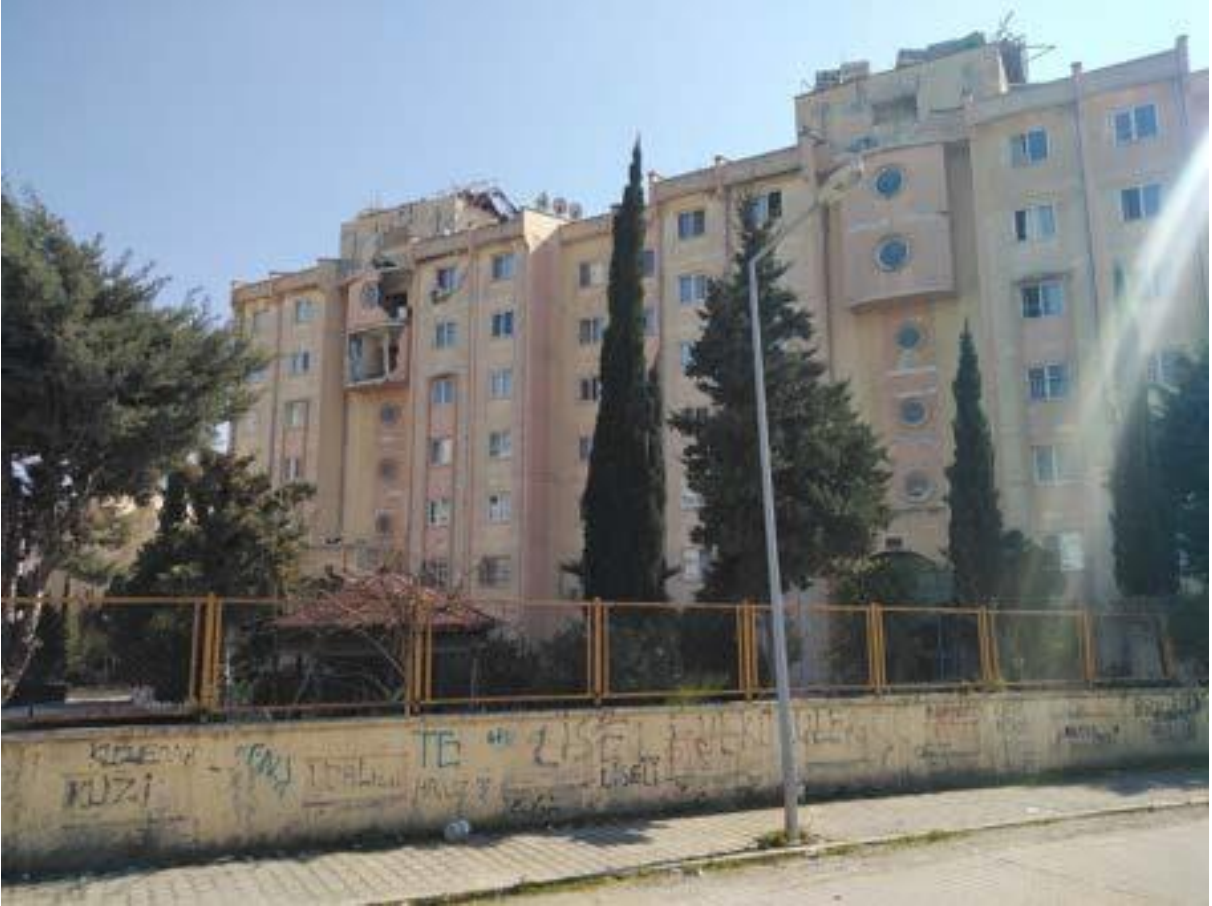
Hatay Altincay neighbourhood TOKİ residences

It was observed that the roofs of TOKİ houses in Altınçay neighbourhood of Hatay had slipped and there were structural damages on the buildings, but security forces prevented an inspection in the area.

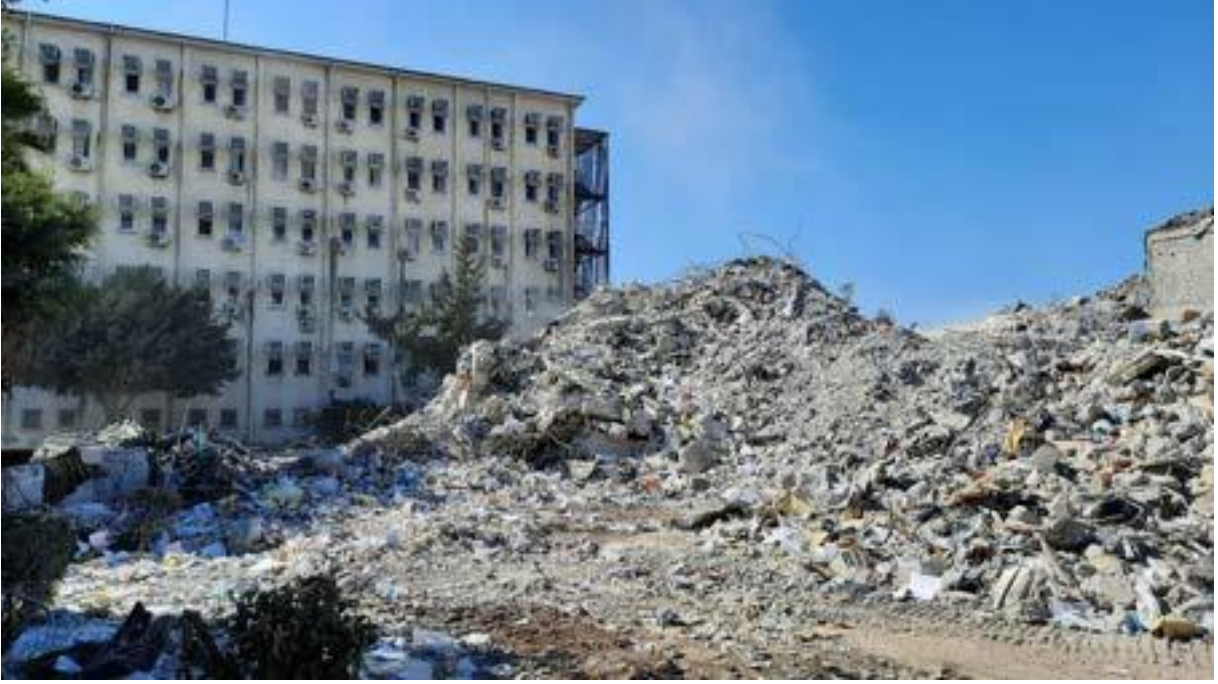
Iskenderun State Hospital collapsed with approximately 150 patients, health workers and patient attendants inside. It is stated that 250-300 people lost their lives in the building. It is learnt that an inspection was carried out in 2011 to determine whether the hospital building was at risk.
