tmmob  
mimarlar  
odası

**6 FEBRUARY 2023**  
**EARTHQUAKES DETECTION**  
**AND EVALUATION REPORT**

**23 FEBRUARY 2023**

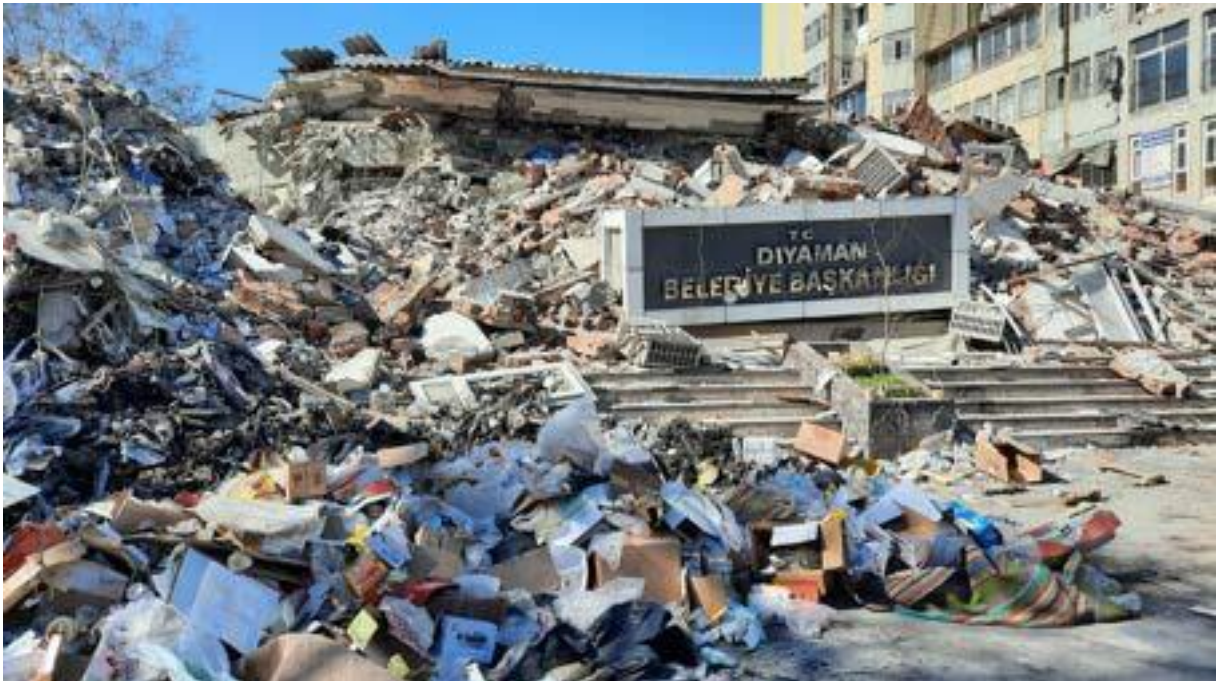
Adiyaman Municipality Building

In Adiyaman, public buildings in the city centre were heavily damaged or destroyed. AFAD building and Adiyaman Municipality building were also destroyed.

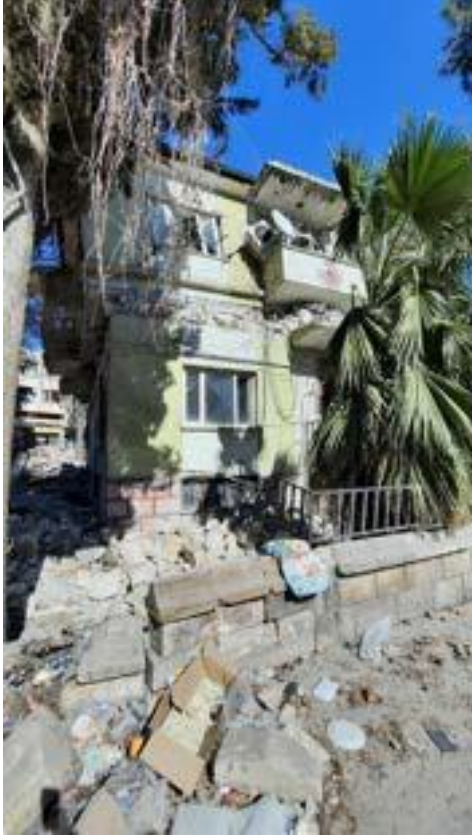
Adiyaman General Directorate of Forestry Lodging Building

It was observed that the General Directorate of Forestry lodging building in the city was heavily damaged.

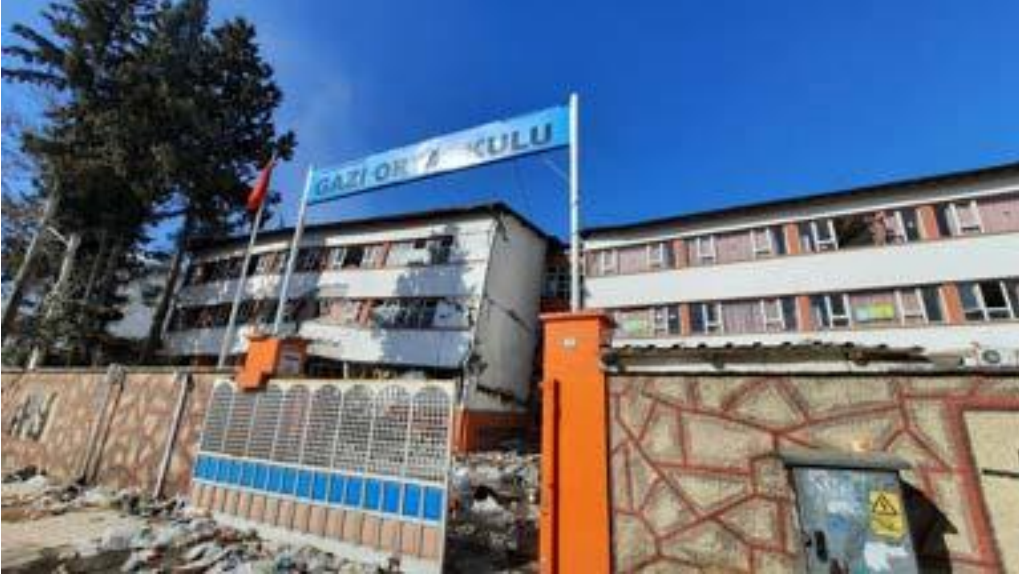
Kahramanmaraş Gazi Secondary School

Gazi Secondary School was heavily damaged in the city.

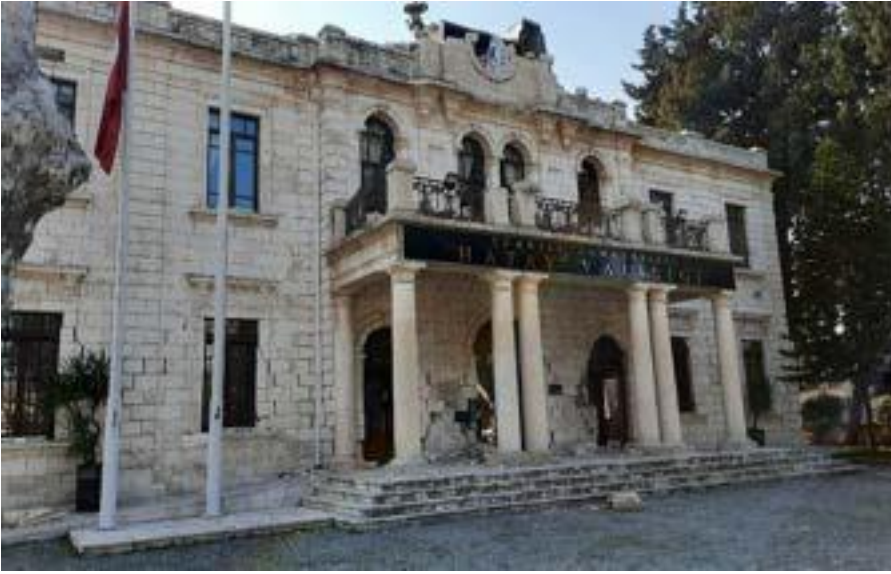
20 February 2023 Following the earthquake in Hatay, the heavily damaged Government House (Governorship) building was demolished. In addition, heavily damaged buildings and registered civil architecture works in the historical texture in and around Kurtuluş Street were demolished.

Hatay Government House (Governorship) damaged after the earthquakes of 6 February 2023

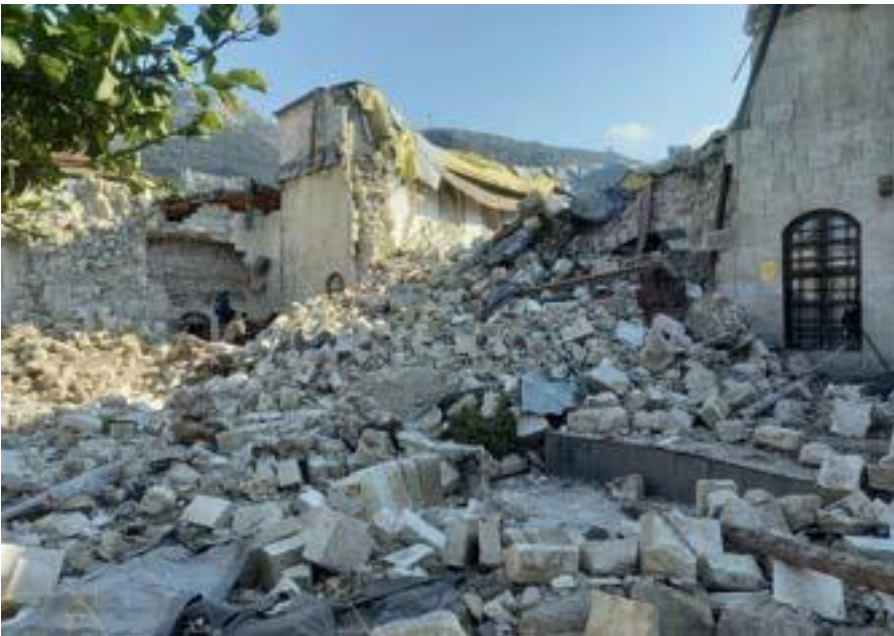
The view of Habib-i Neccar Mosque in Hatay after the earthquakes of 6 February 2023

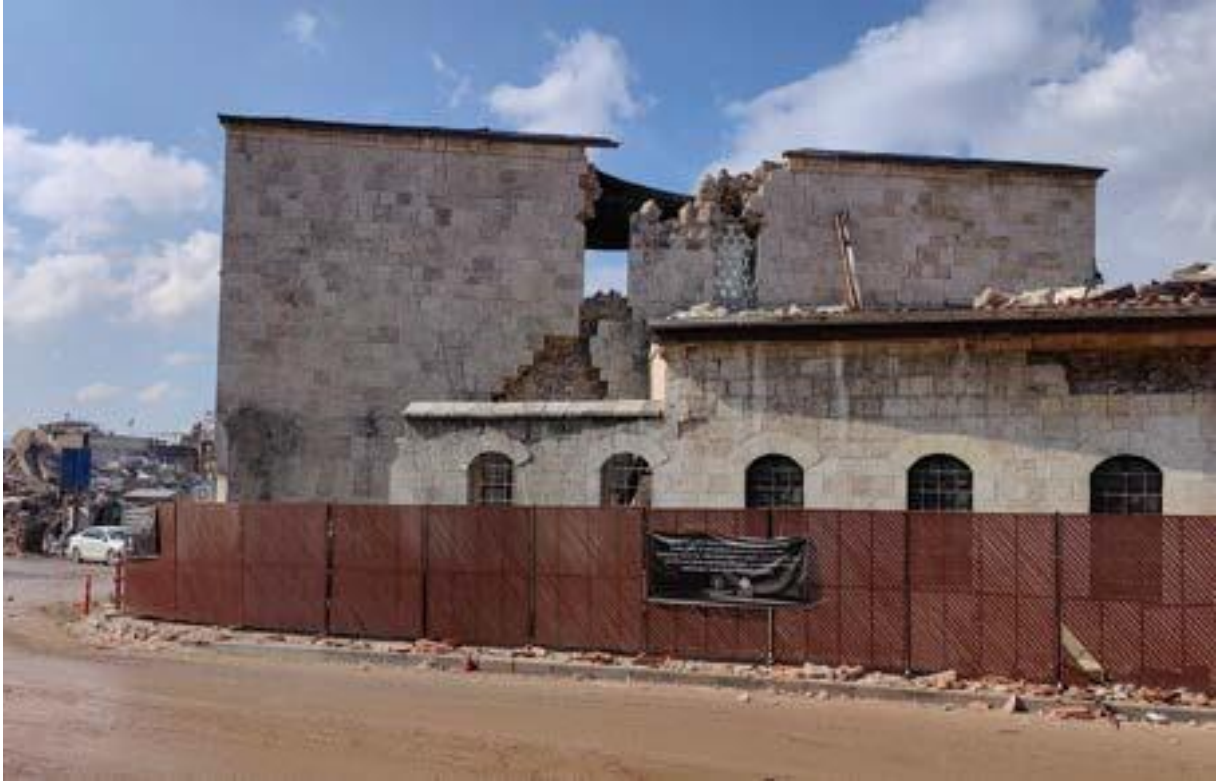
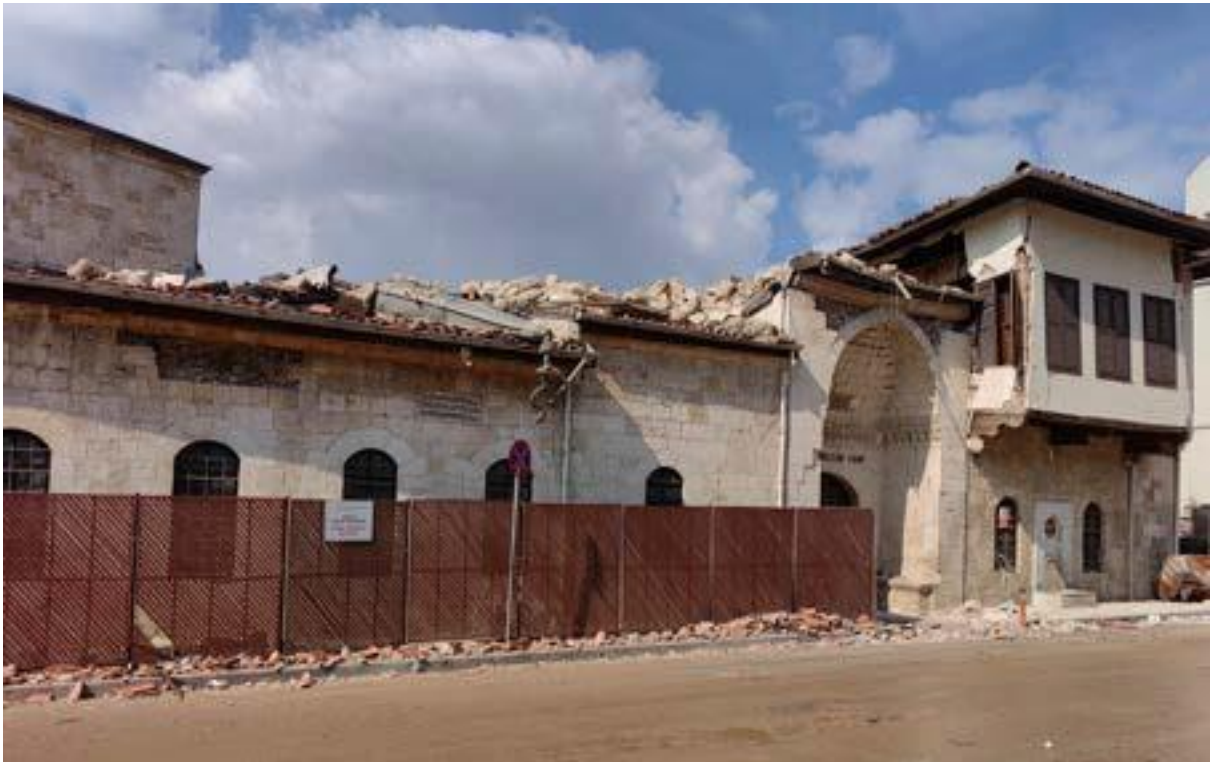
View of Habib-i Neccar Mosque, Hatay, after the earthquake of 20 February 2023

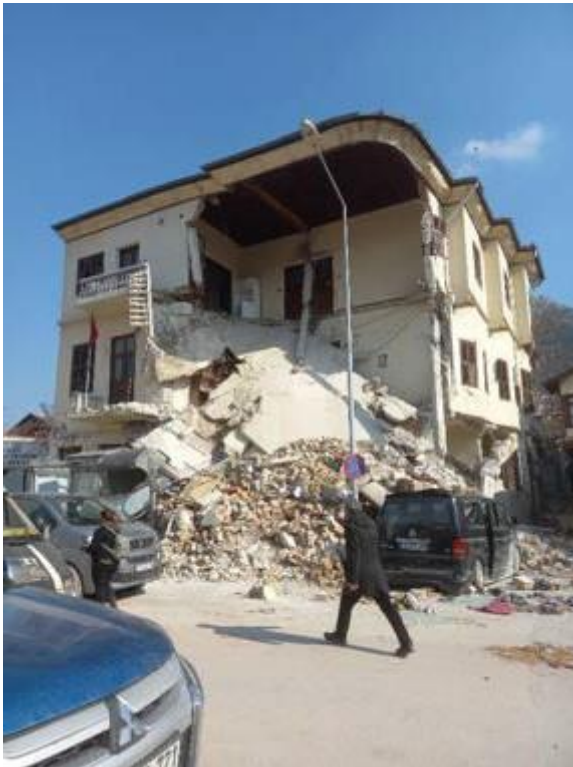
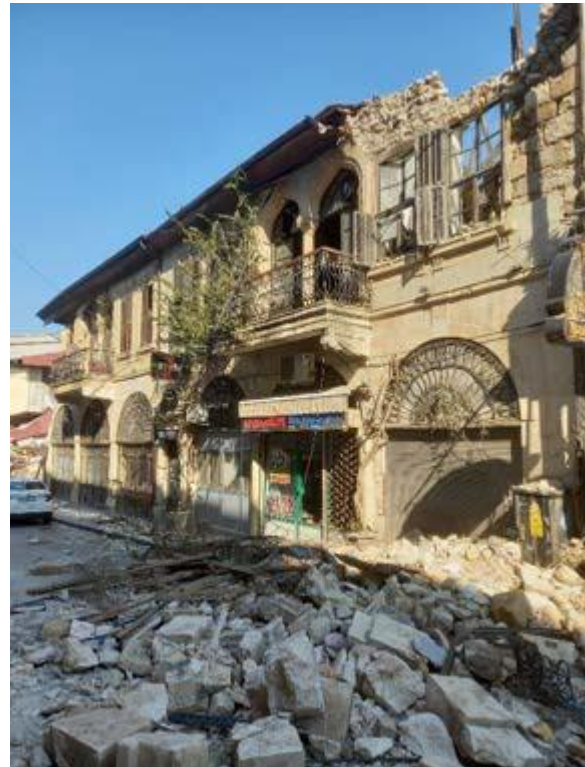
Examples of damages to civil architecture works in the historical city centre of Antakya after the earthquake of 6 February 2023 (Photograph: Assoc. Prof. Dr. Koray Güler)

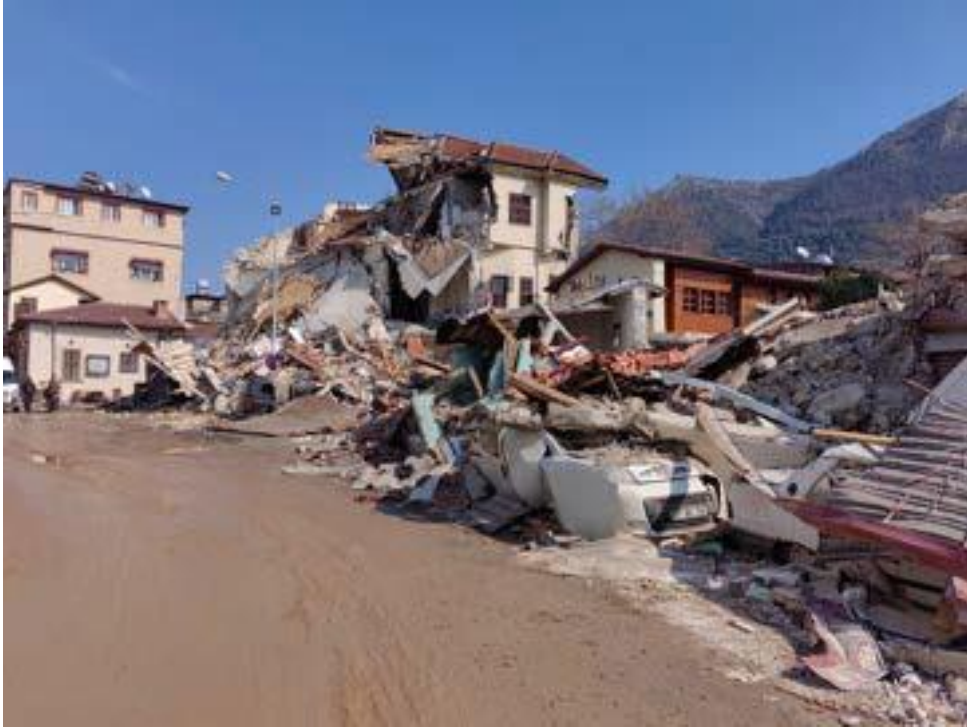
Examples of damages to civil architecture works in the historical city centre of Antakya after the earthquake of 20 February 2023 (Photograph: Assoc. Prof. Dr. Koray Güler)

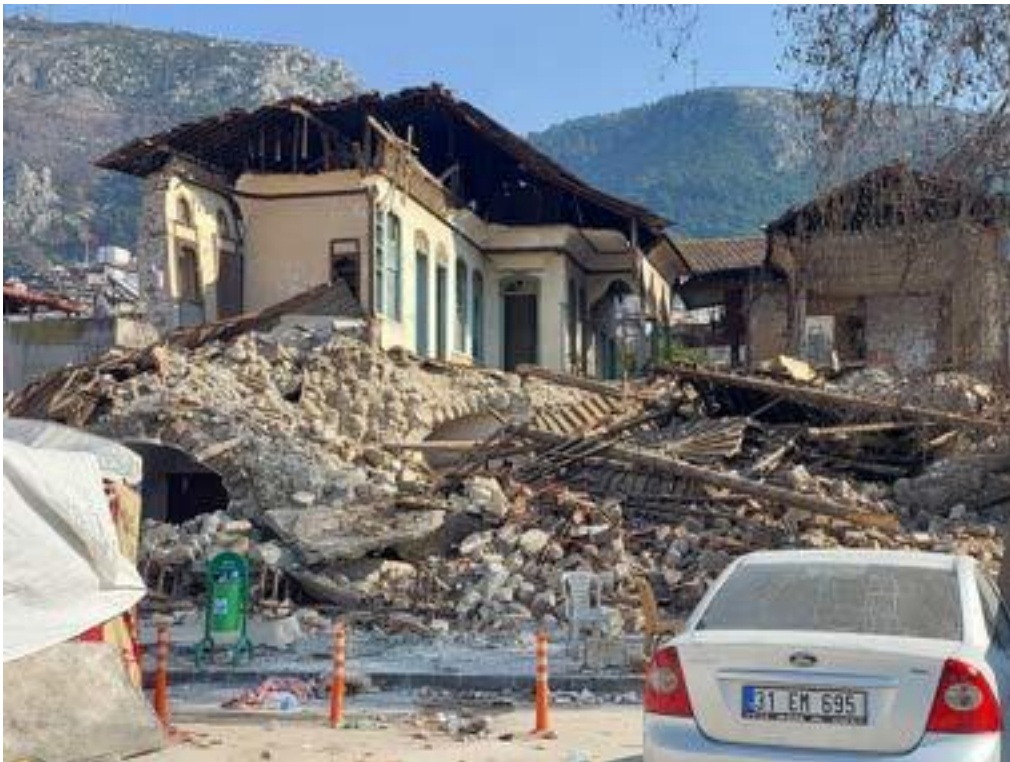
Examples of damages to civil architectural works in the historical city centre of Antakya caused by the earthquake of 6 February 2023

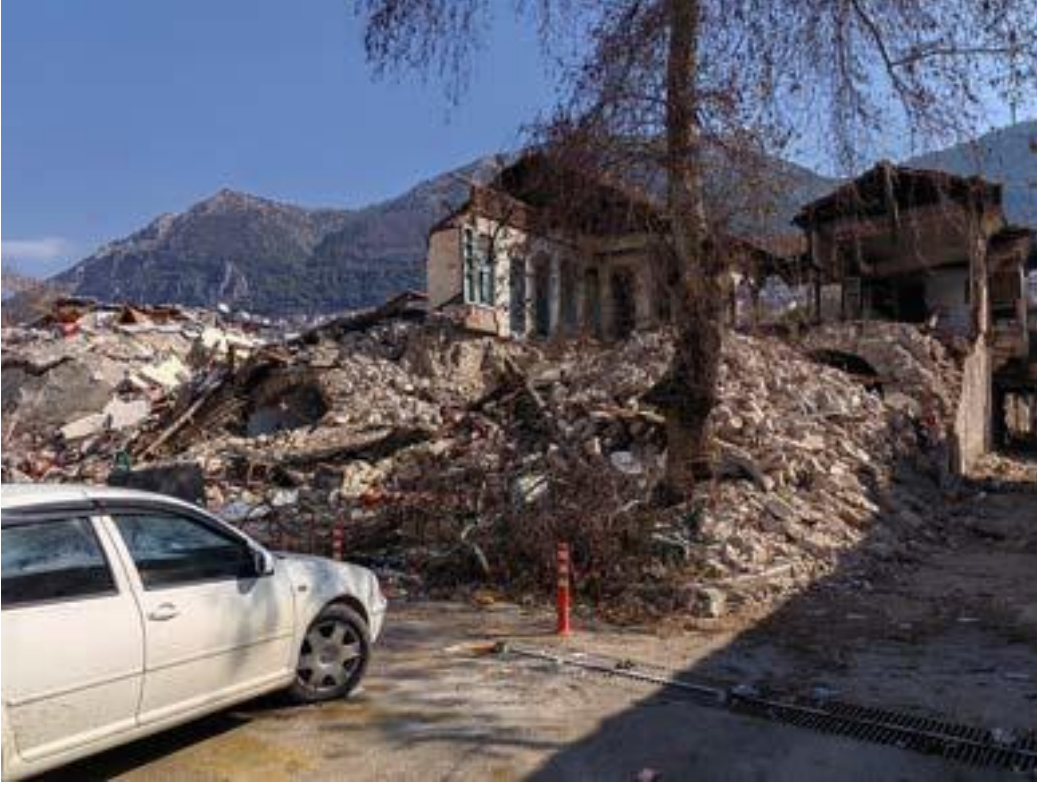
Examples of damages to civil architectural works in the historical city centre of Antakya caused by the earthquake of 20 February 2023

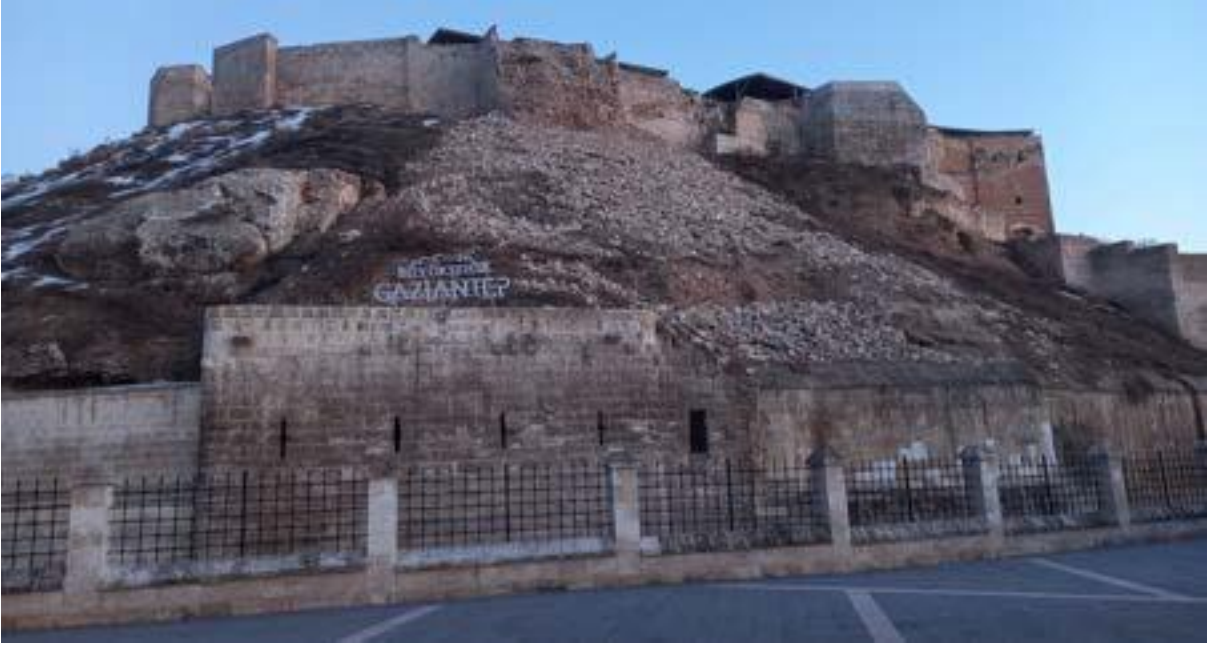
Structural cracks were observed in the bastions of Gaziantep Castle and collapsed sections of the city walls. It was also observed that the minaret of the Şirvanlı Mosque, located near the castle, collapsed and a part of the body walls were damaged. Similarly, it was observed that the dome and minarets of the Kurtuluş Mosque collapsed.

Damages observed in Gaziantep Castle after the earthquake (Photograph: Assoc. Prof. Dr. Koray Güler)

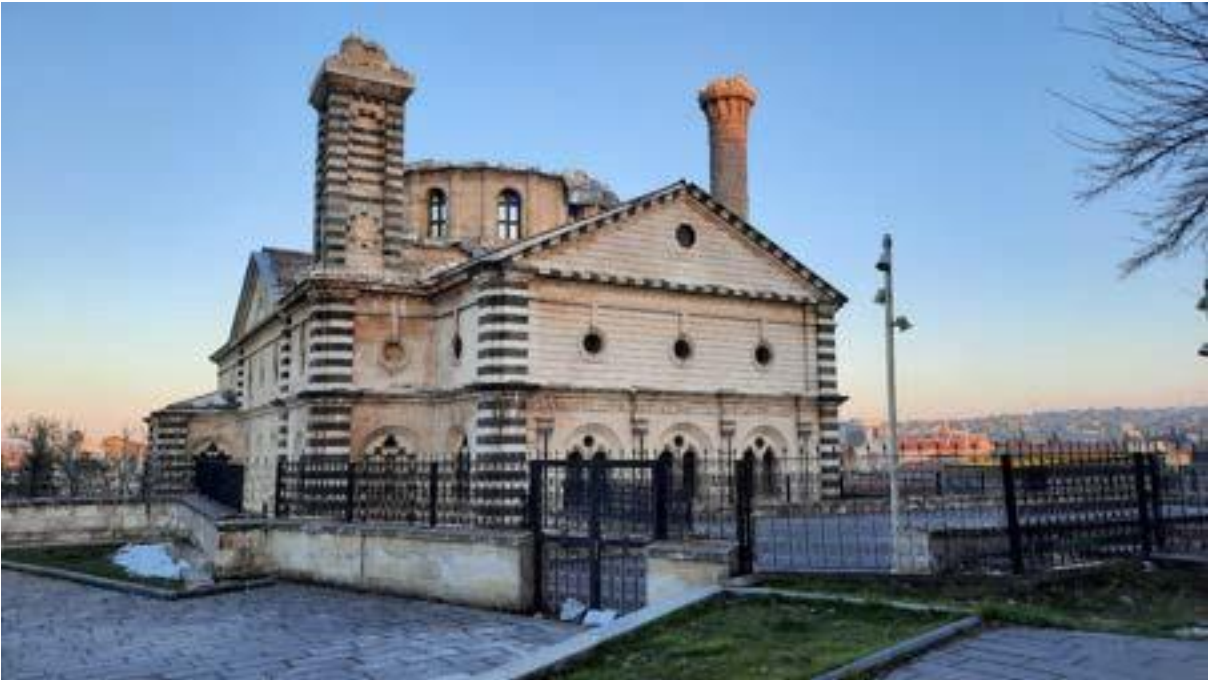
Damages observed in Kurtuluş Mosque after the earthquake

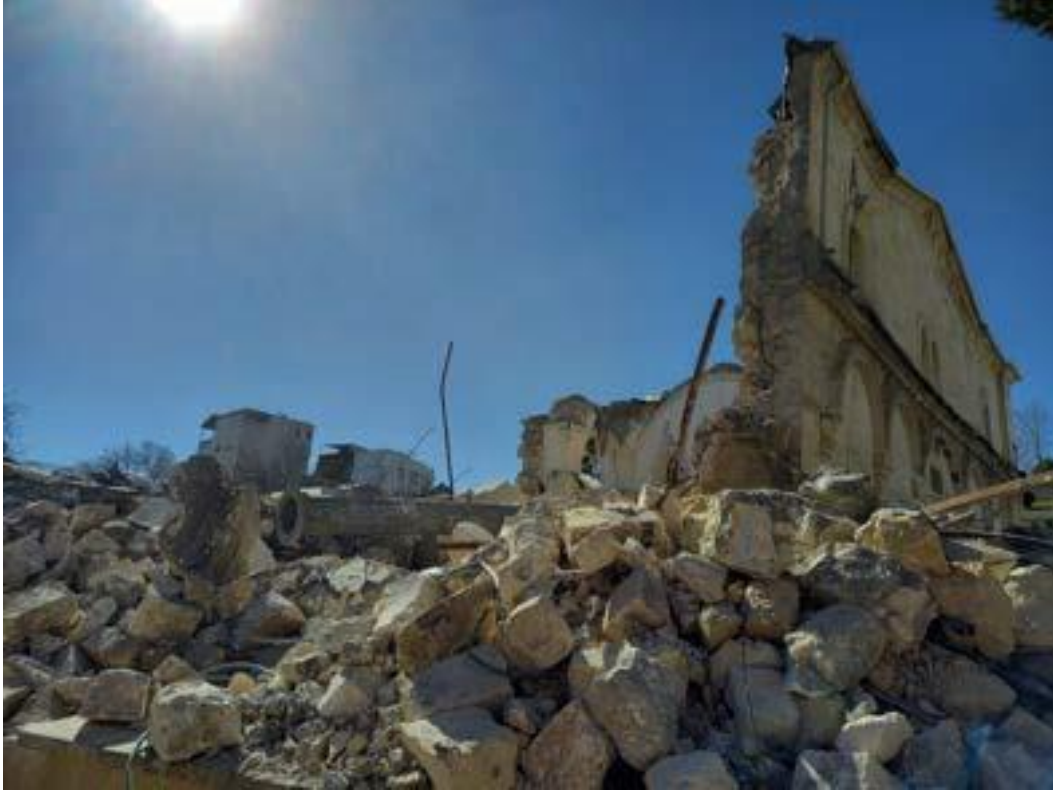
The Grand Mosque in Adiyaman was heavily damaged and only two body walls of the building survived. Similarly, the Old Palace Mosque in the city centre was also heavily damaged and its minaret collapsed.

Damages observed in Adiyaman Ulu Mosque after the earthquake (Photograph: Assoc. Prof. Dr. Koray Güler)

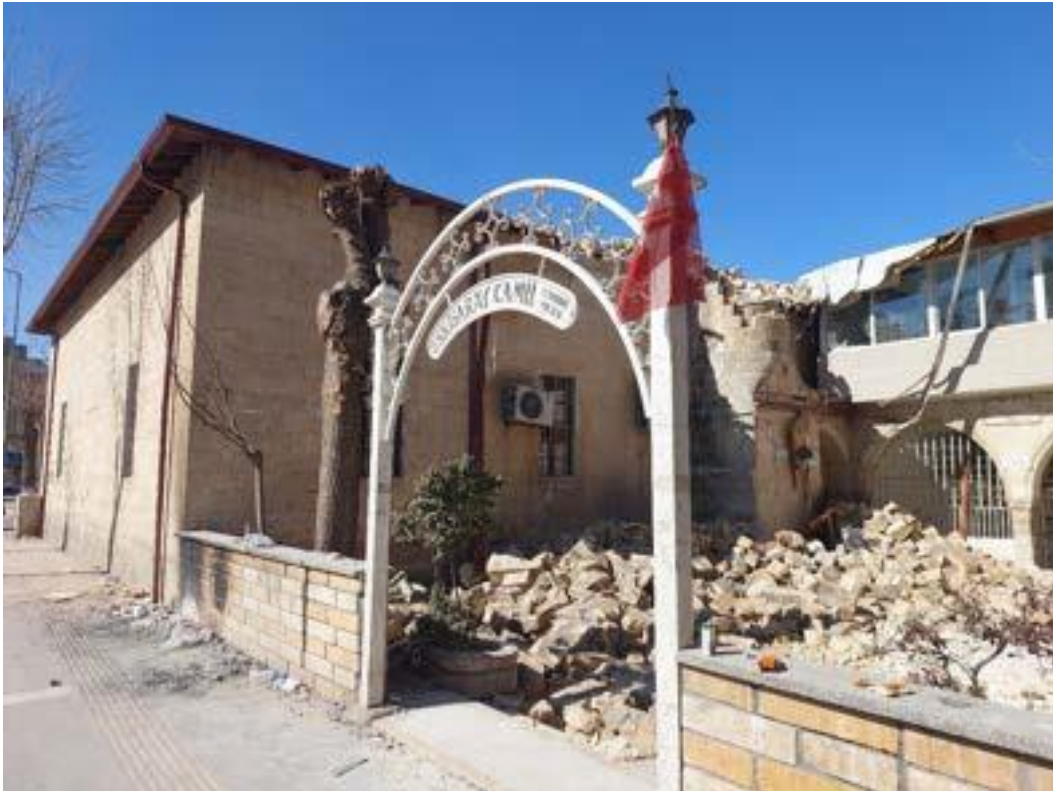
Damages observed in Adiyaman Eski Saray Mosque after the earthquake

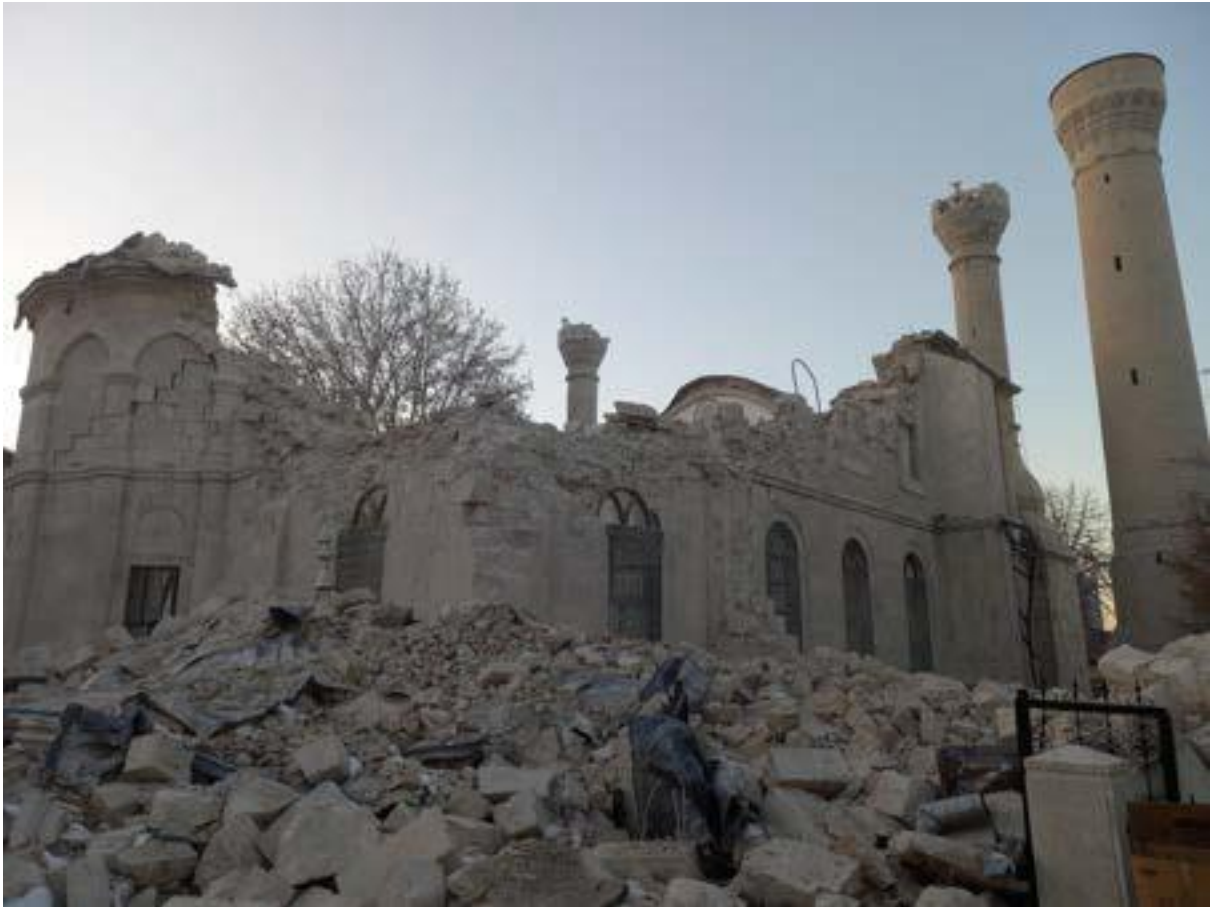
In addition, it is understood that although it is stated in the decisions of the Regional Board for the Protection of Cultural Assets regarding the Yeni Mosque that the building was damaged in previous earthquakes, most recently in the 2020 Elazığ-Sivrice earthquake, the necessary measures were not taken.

Damages observed in Malatya Ulu Mosque after the earthquake (Photograph: Assoc. Prof. Dr. Koray Güler)

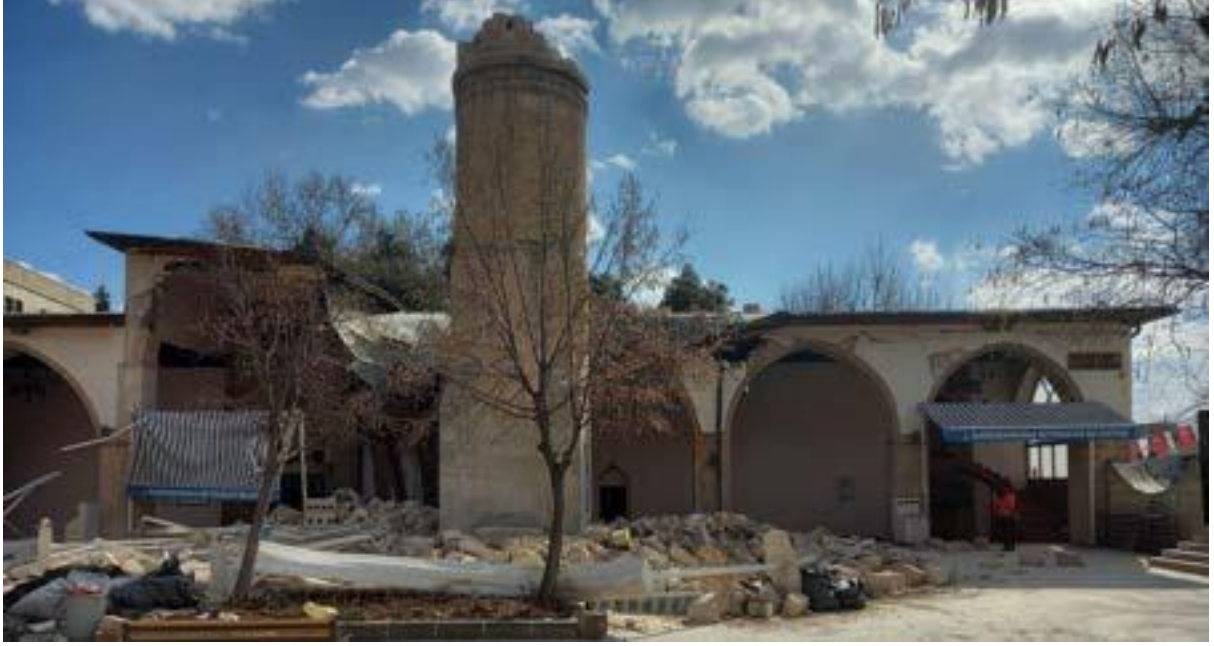
The minaret of Kahramanmaraş Ulu Mosque collapsed and the last congregation area was severely damaged. Similarly, it was observed that the minaret of Arasa Mosque was also destroyed. Damages were also observed in the civil architecture works in the city centre and the castle.

Damages observed in Kahramanmaraş Ulu Mosque after the earthquake  
(Photograph: Assoc. Prof. Dr. Koray Güler)

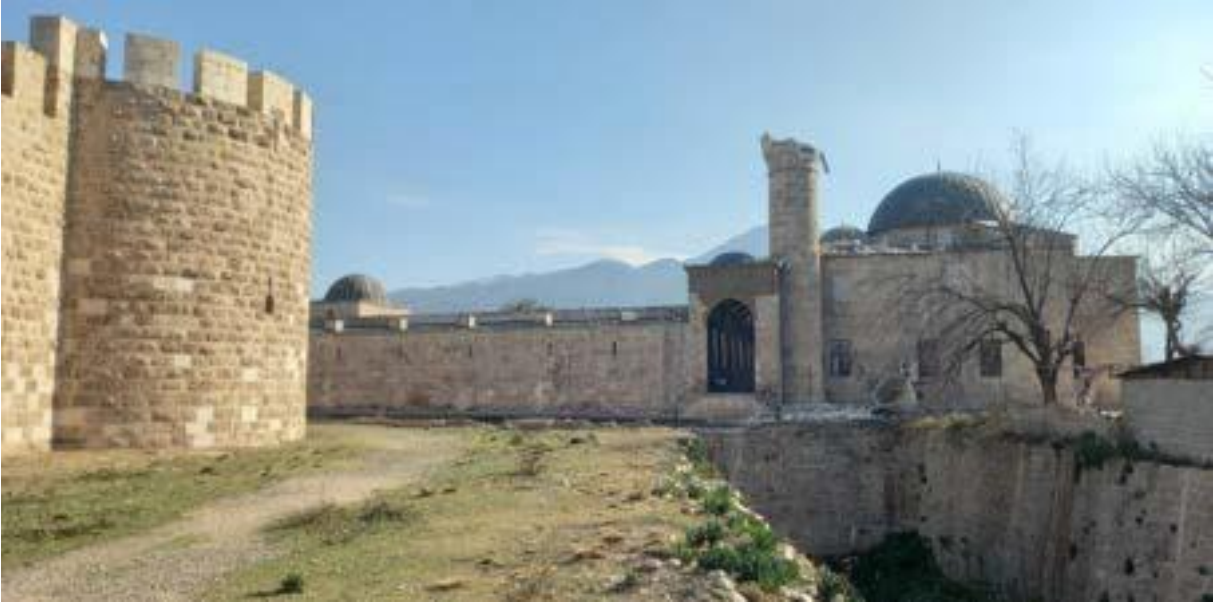
In Sokollu Complex, a work of Mimar Sinan in Payas, the minaret of the mosque was destroyed. No damage was observed in the castle. In the caravanserai section, structural cracks and plaster spillages were observed in the portico domes where it was understood that seams were made in previous restoration applications.

Damages observed in Payas Sokollu Mosque after the earthquake (Photograph: Assoc. Prof. Dr. Koray Güler)

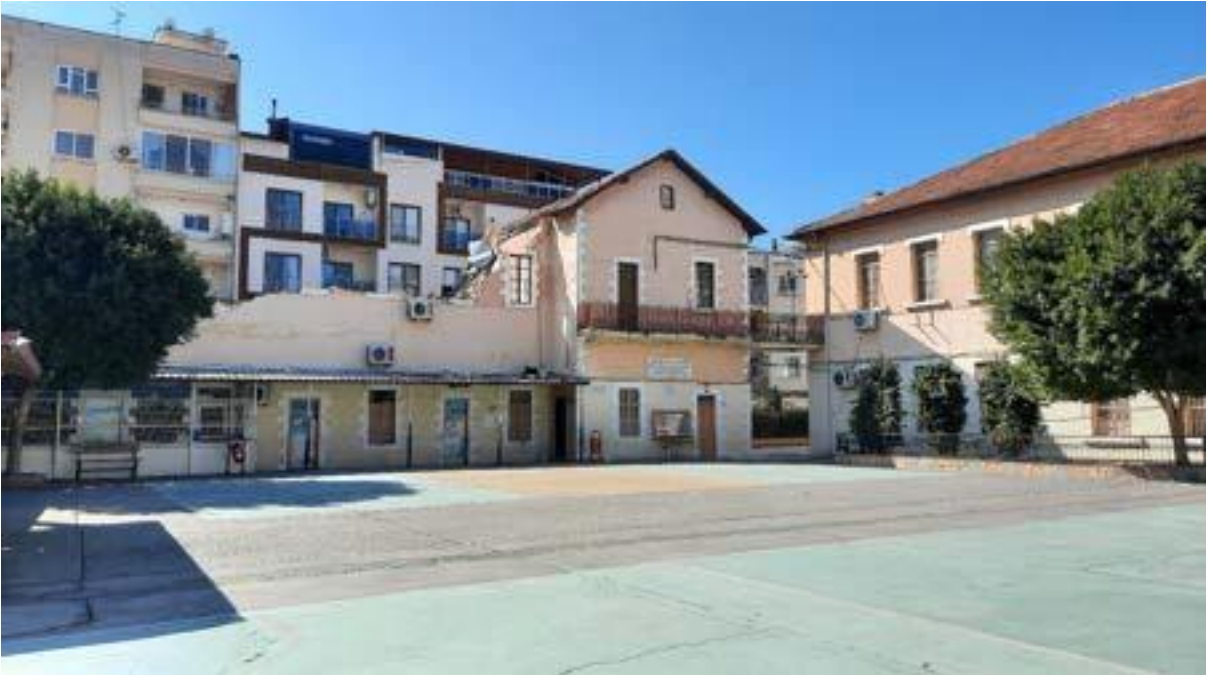
There are partial collapses in the former French Embassy building, which is now used as Mithatpaşa Secondary School in Iskenderun. The Latin Catholic Church, which is still in active use today, was largely destroyed, while the Orthodox Church was severely damaged.

The former French Embassy, which is used as Iskenderun Mithatpaşa Secondary School, was damaged after the earthquake.

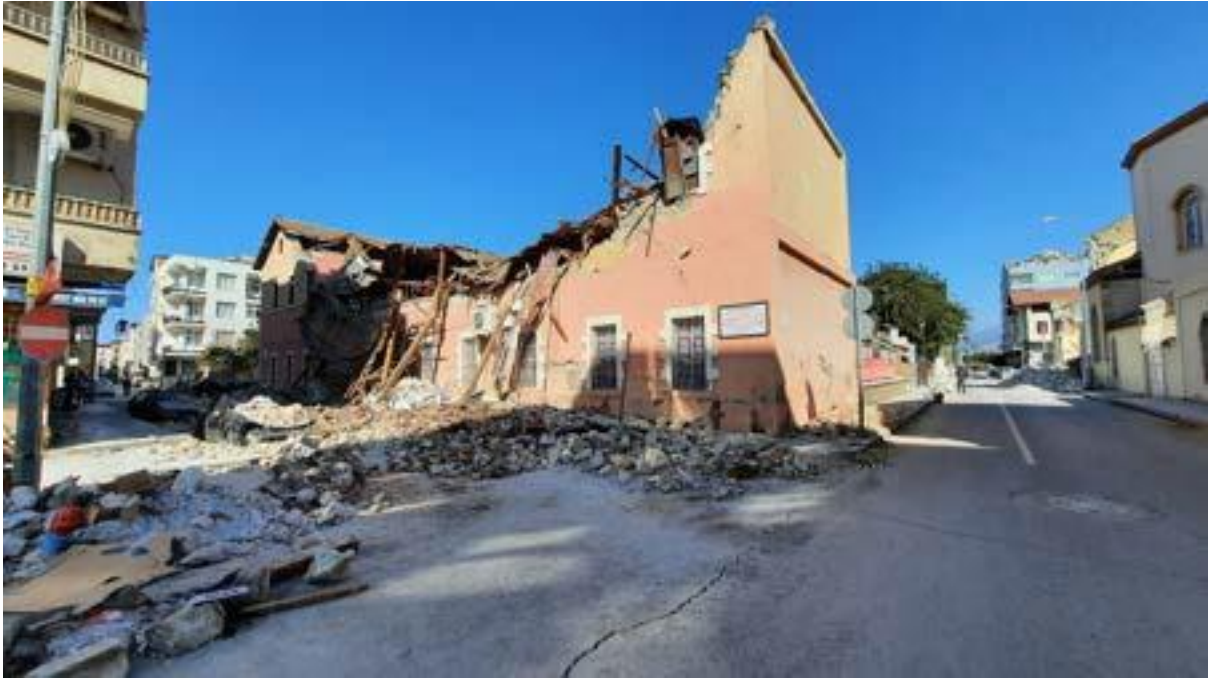
The former French Embassy, which is used as Iskenderun Mithatpaşa Secondary School, was damaged after the earthquake.

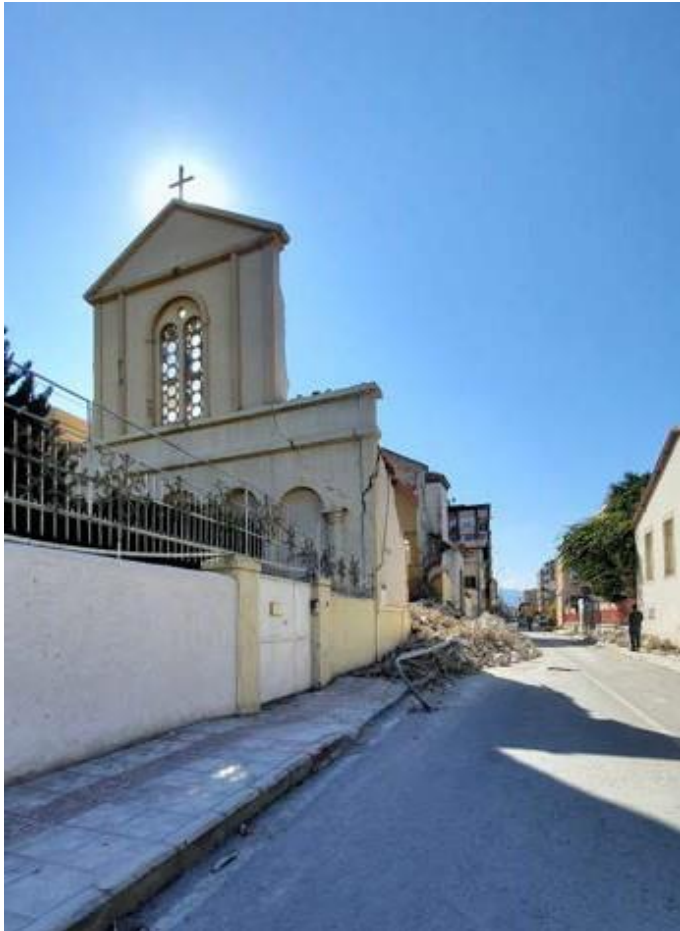
Iskenderun Latin Catholic Church after earthquake damage

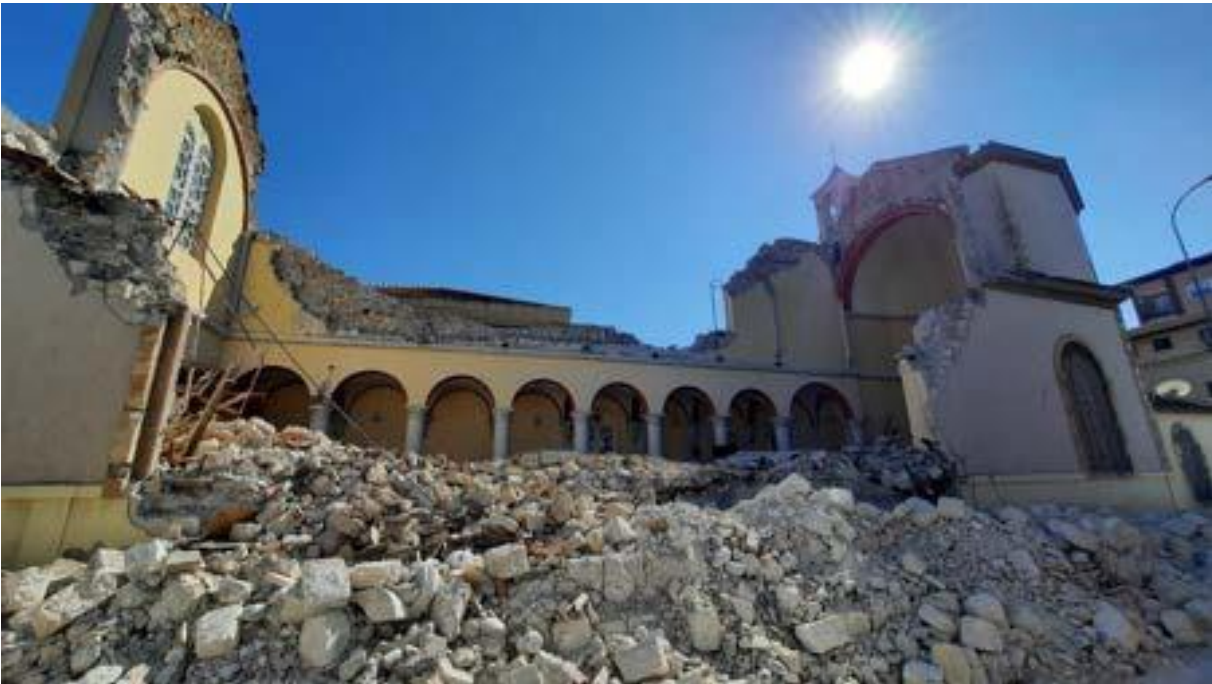
Iskenderun Latin Catholic Church after earthquake damage

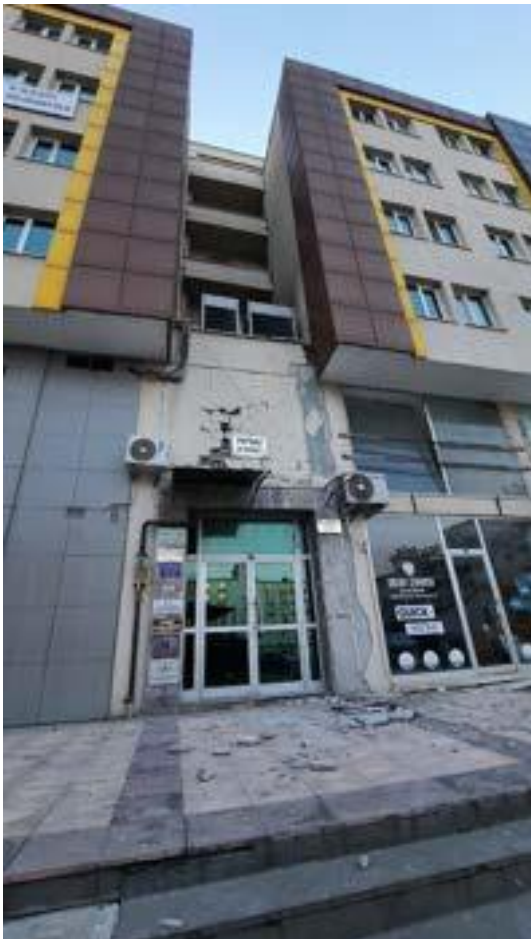
Business Centre building where the Chamber of Architects Osmaniye Representative Office is located

It was informed that Poyraz Business Centre, where the Chamber of Architects Osmaniye Representative Office is located, was built after 2010. It was observed that there were structural damages in the building, but it could not be examined since no damage assessment was made.

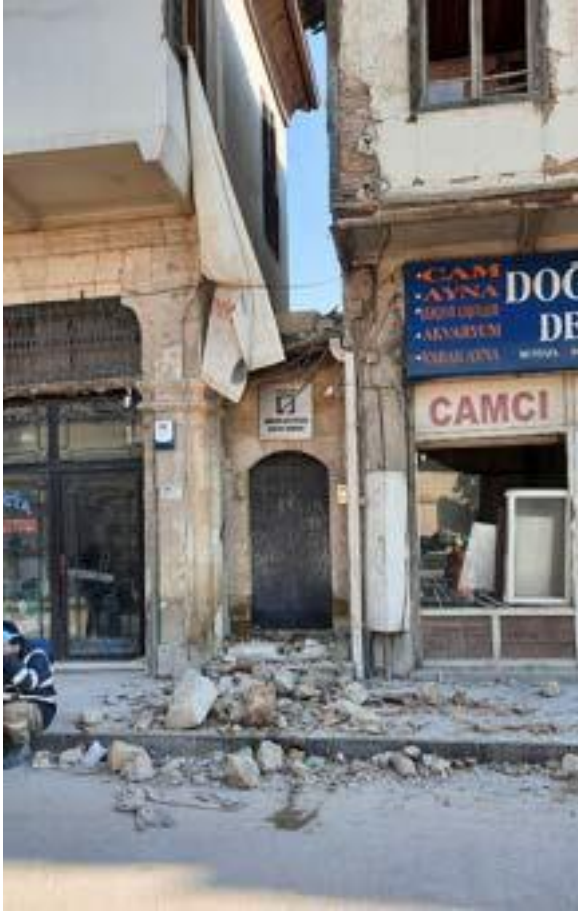
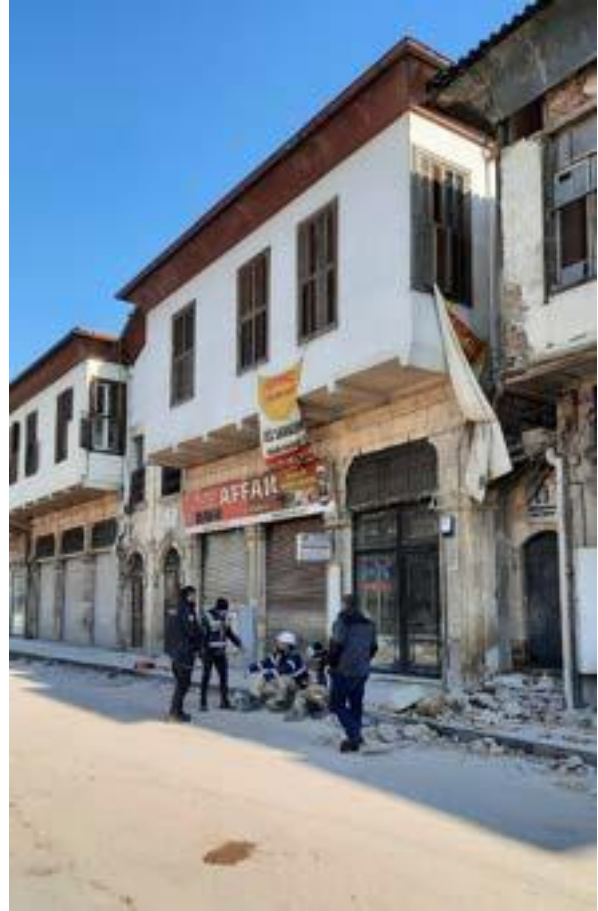
Chamber of Architects Hatay Branch Registered Historical Building

Although there is no damage to the registered building, which belongs to our Chamber, where the Chamber of Architects Hatay Branch operates, there is heavy damage to the buildings next to the building and on the street where it is located. There is also a need for a re-evaluation after the earthquake in Hatay on 20 February 2023.

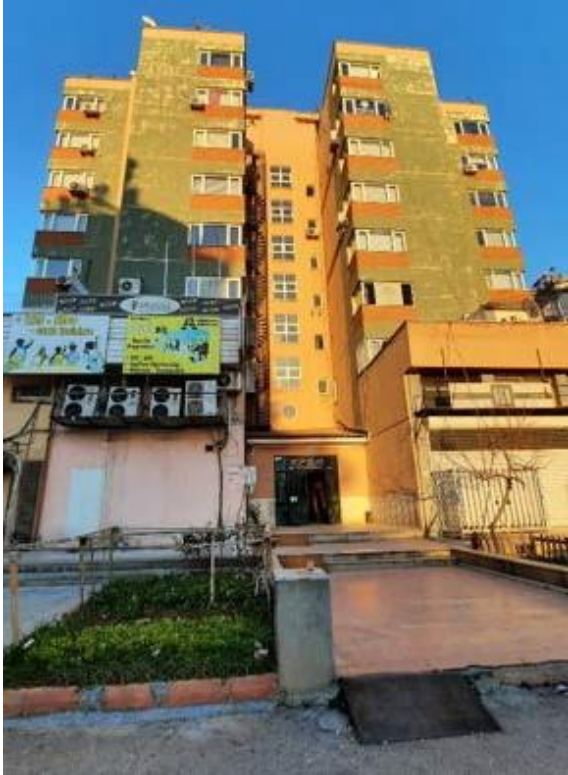
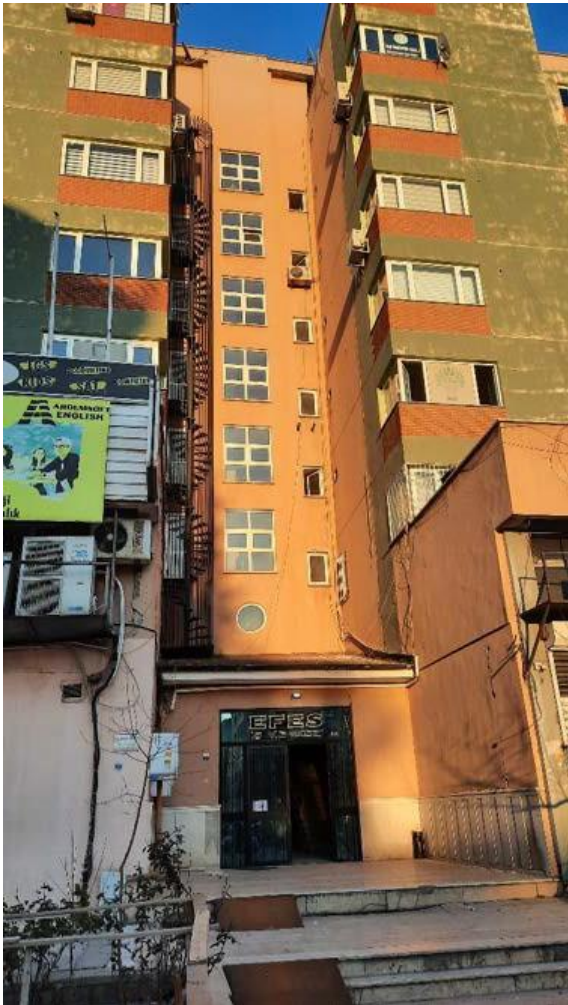
Business Centre building where the Chamber of Architects Gaziantep Branch is located

Structural damages were observed in the Efes Business Centre, where the Gaziantep Branch of the Chamber of Architects is located, which was completed in 2002, but the building could not be examined since no damage assessment was carried out.

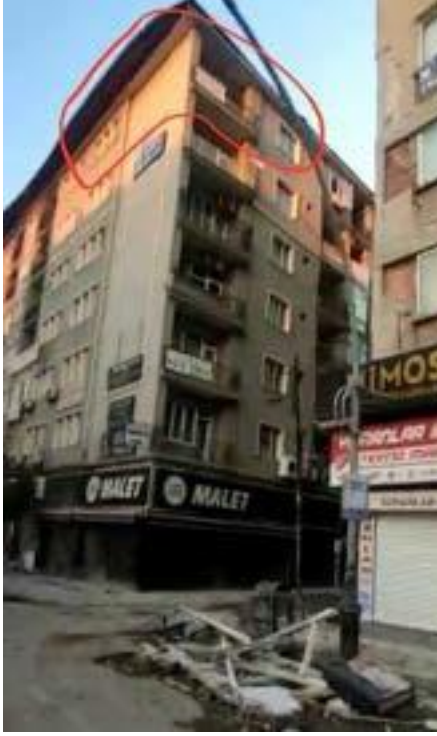
Since the building where the Chamber of Architects Malatya Branch operates was heavily damaged, the building could not be examined in detail.
