tmmob  
mimarlar  
odası

**6 FEBRUARY 2023**  
**EARTHQUAKES DETECTION**  
**AND EVALUATION REPORT**

**23 FEBRUARY 2023**

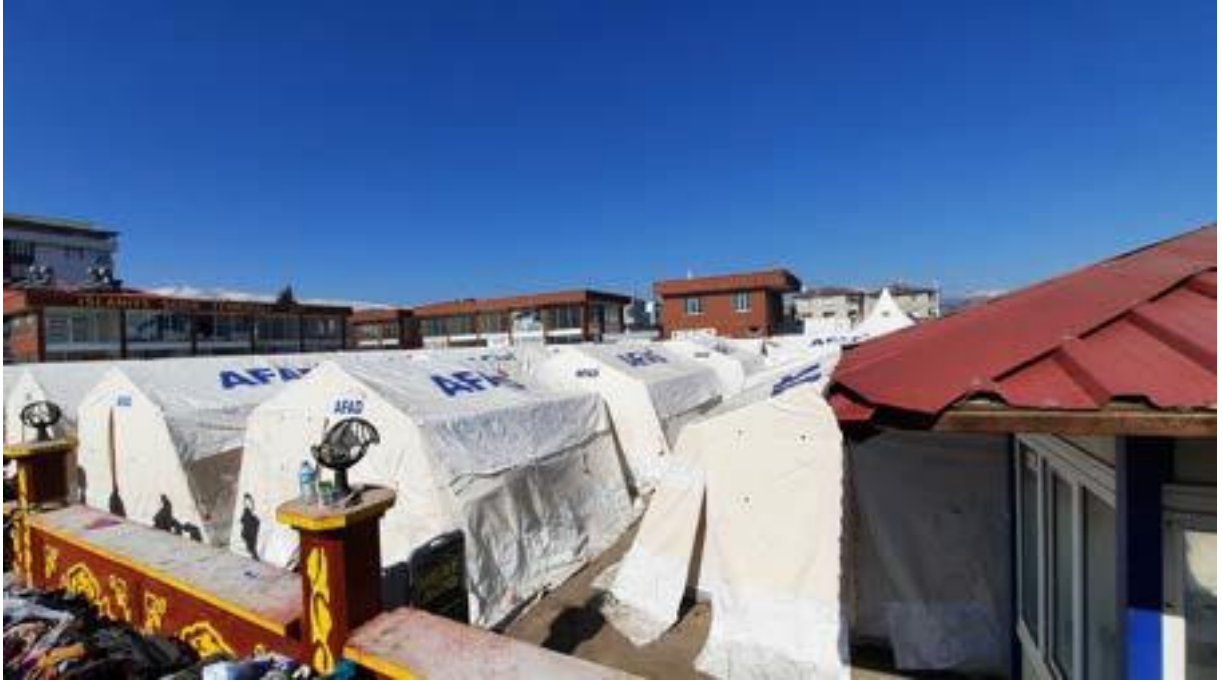
Islahiye - Bus Terminal tent compound

It was observed that a tent settlement was established in front of the bus terminal in Islahiye. However, it was observed that fire, epidemics and security problems may occur due to the irregular and close proximity of the tents.

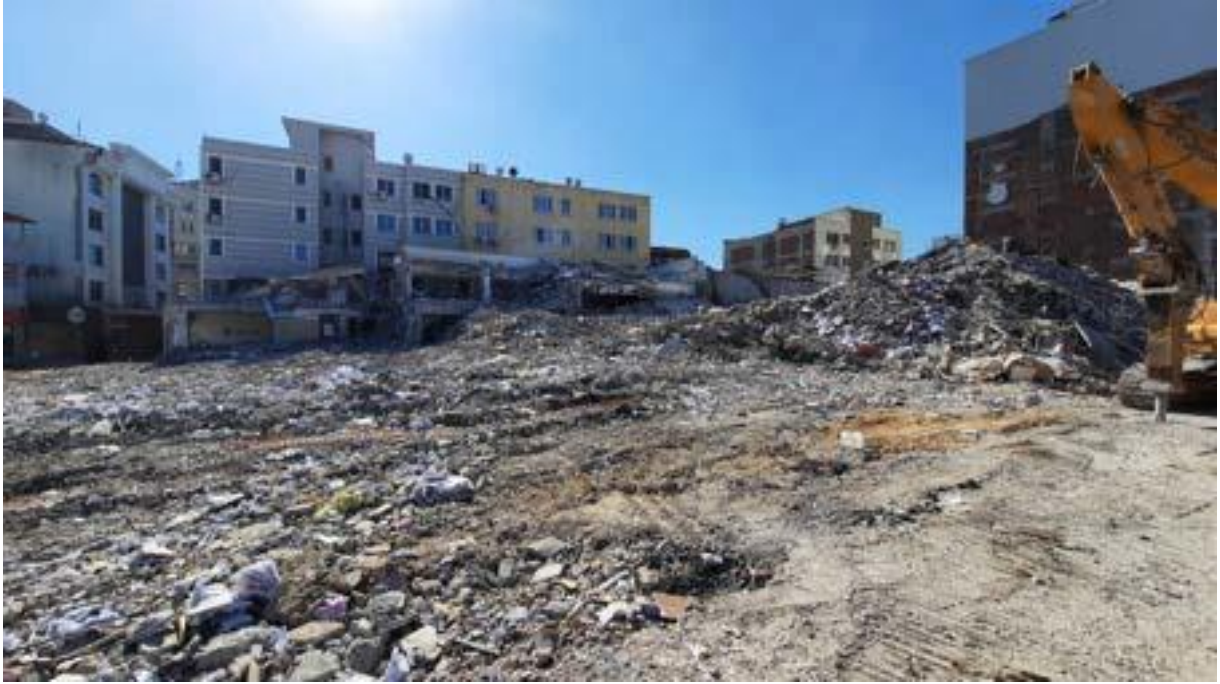
Adiyaman ISIAS Hotel

Many buildings on Atatük Boulevard have been demolished or heavily damaged. Isias Hotel located on this boulevard was also demolished.

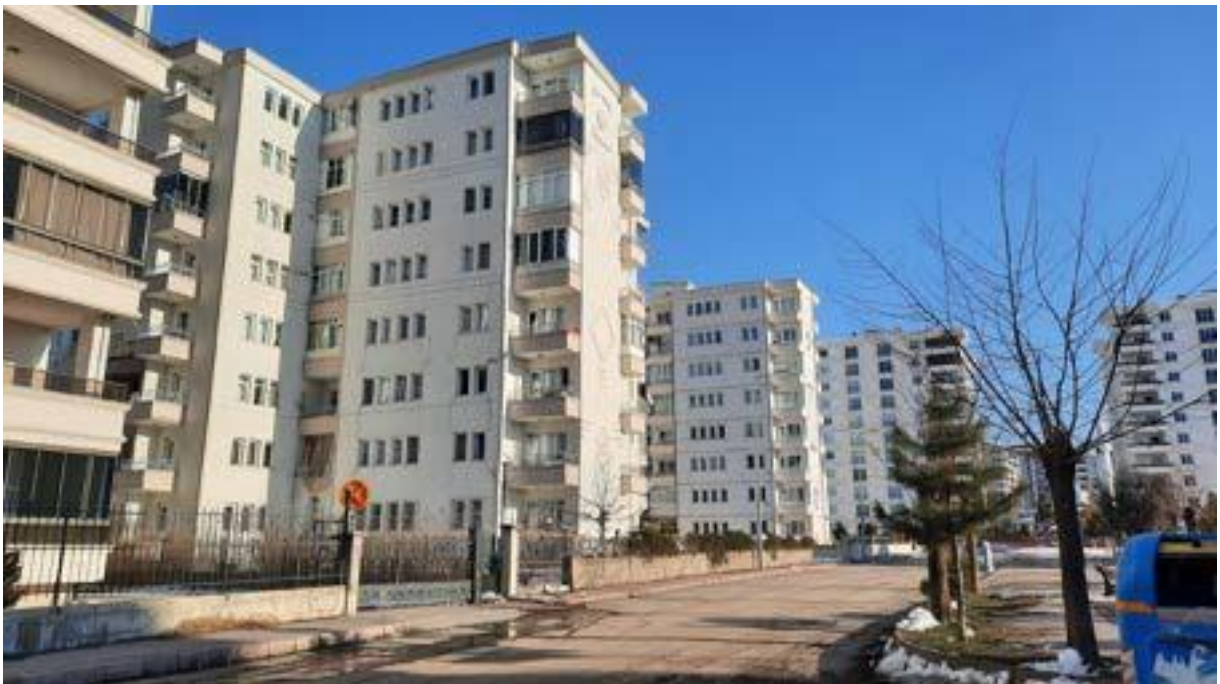
Malatya Bostanbasi Neighbourhood

Bostanbaşı neighbourhood was used for agricultural purposes for apricot gardens in the past, but in the last 10 years, the zoning plans have been changed and opened to construction, the 5-storey restriction has been removed and the building heights have been left free, that is, h = free regulation has been introduced. The ground of the region is not suitable for high-rise construction.

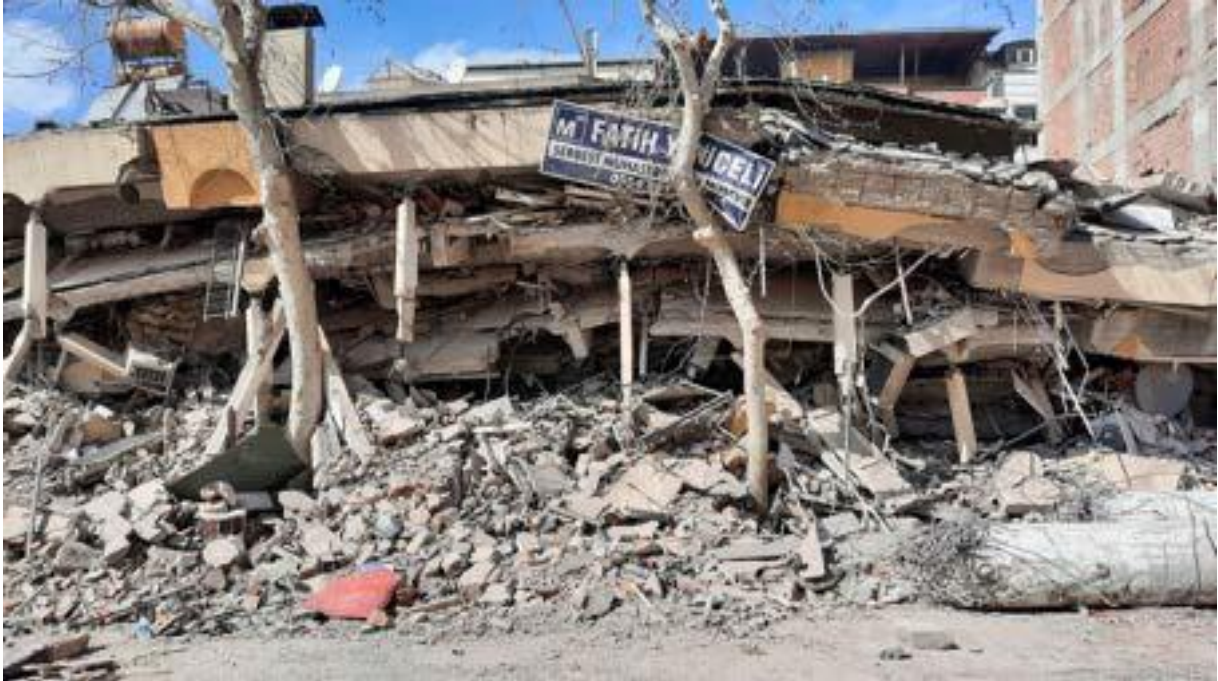
Kahramanmaraş city centre

It was observed that most of the multi-storey buildings on Sandalzade, Azerbaijan and Trabzon Boulevards were severely damaged and collapsed.

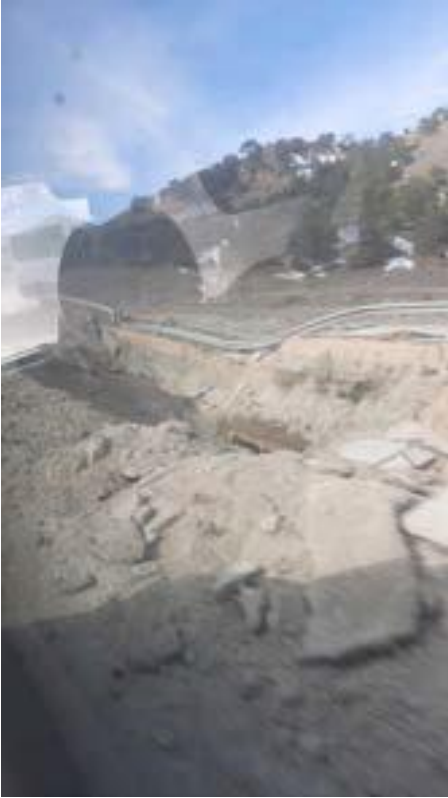
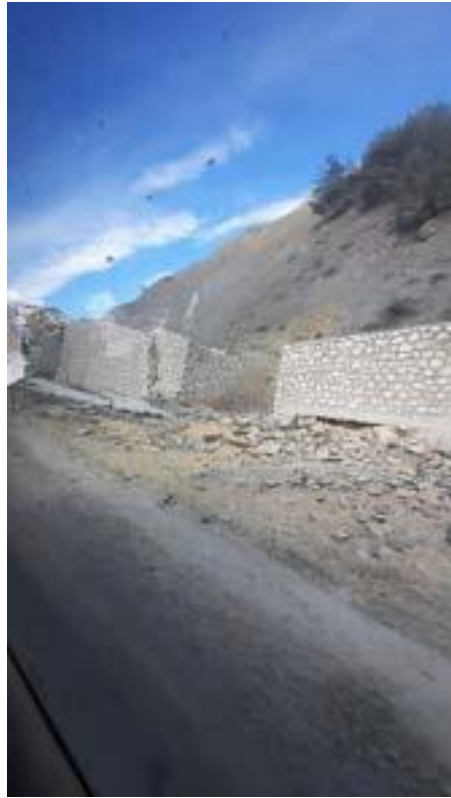
Kahramanmaraş-Malatya divided road slides and collapses

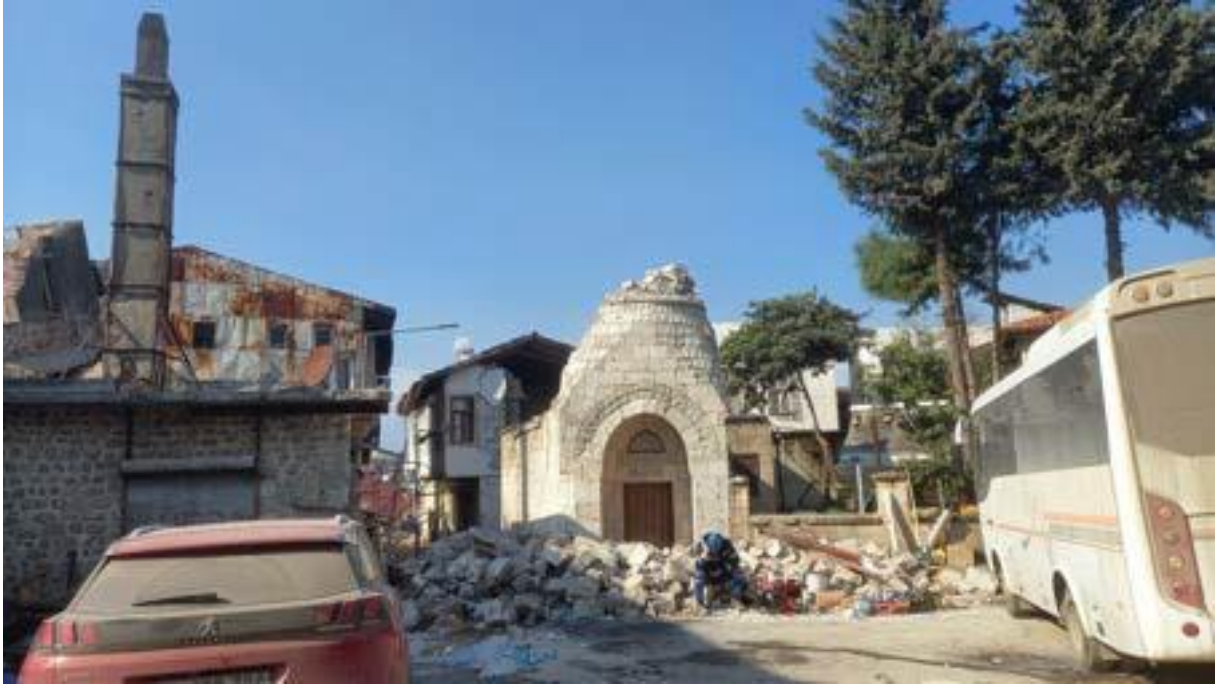
In Hatay, the Government House (Governor's Office), Habib-i Neccar Mosque, Great Mosque, Sarımiye Mosque, Antakya Synagogue, St. Paul Orthodox Church and Hatay Assembly were severely damaged or largely destroyed. Today, these sites are located within the borders of

Post-earthquake view of Sarimiye Mosque in Hatay (Photograph: Assoc. Prof. Dr. Koray Güler)

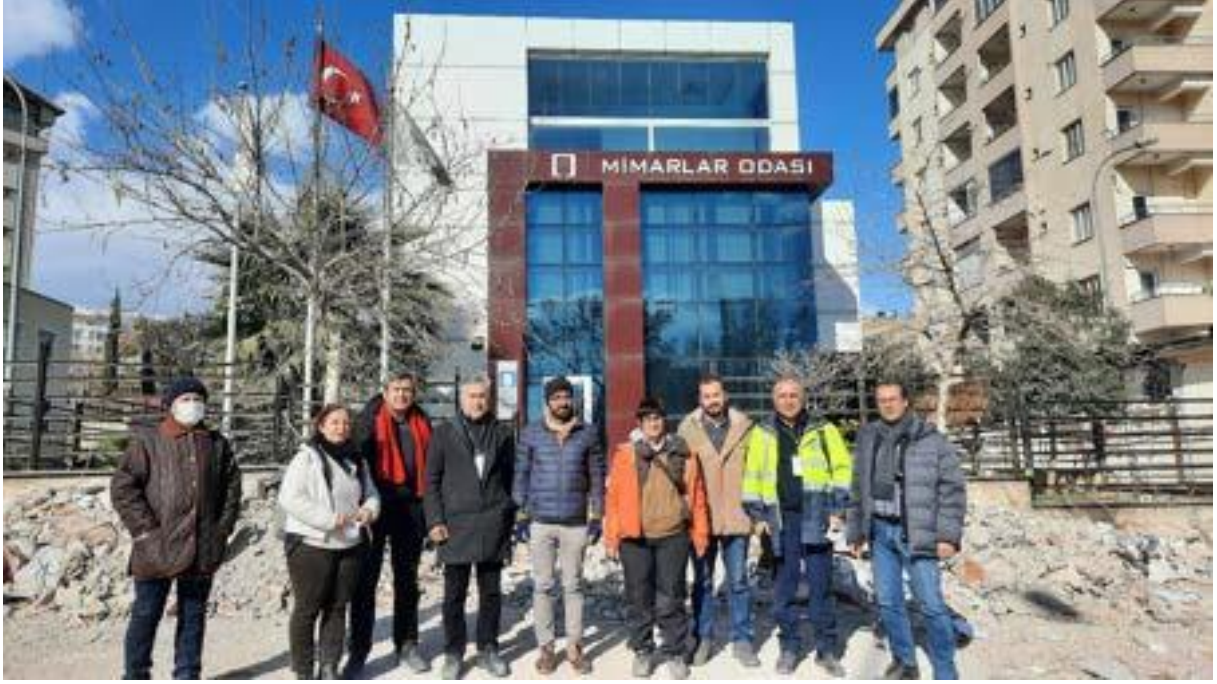
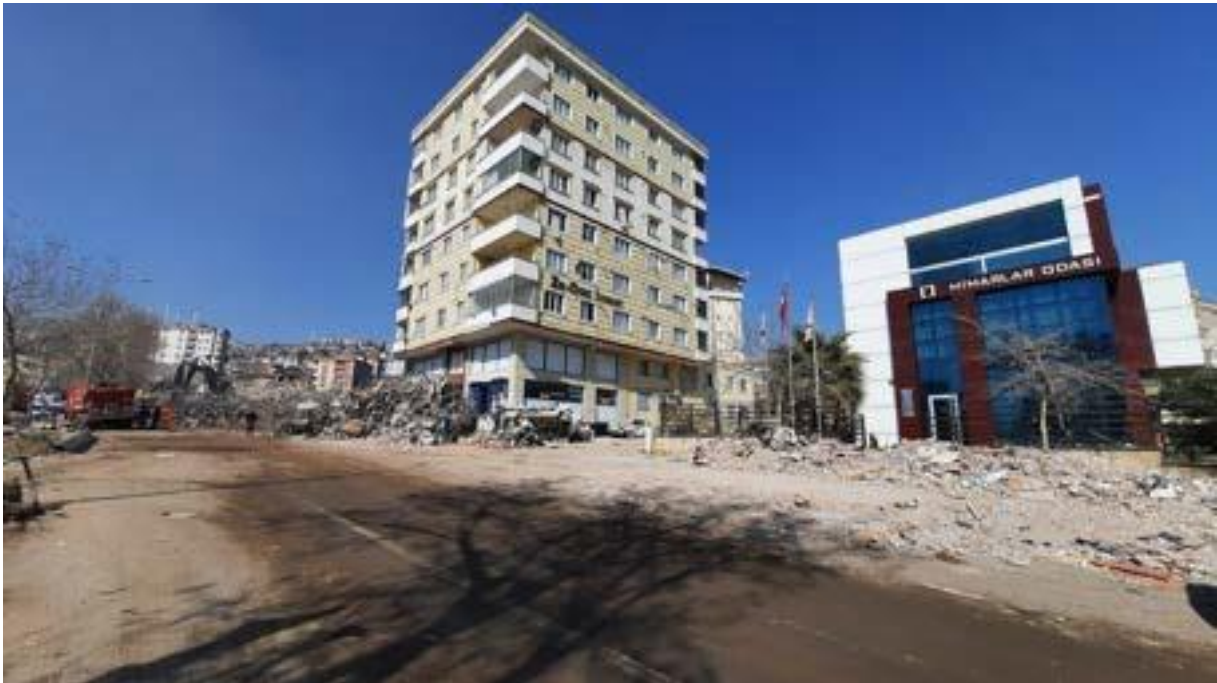
Chamber of Architects Kahramanmaraş Branch Building

It has been determined that the building owned by our Chamber, where the Chamber of Architects Kahramanmaraş Branch operates, was not damaged.

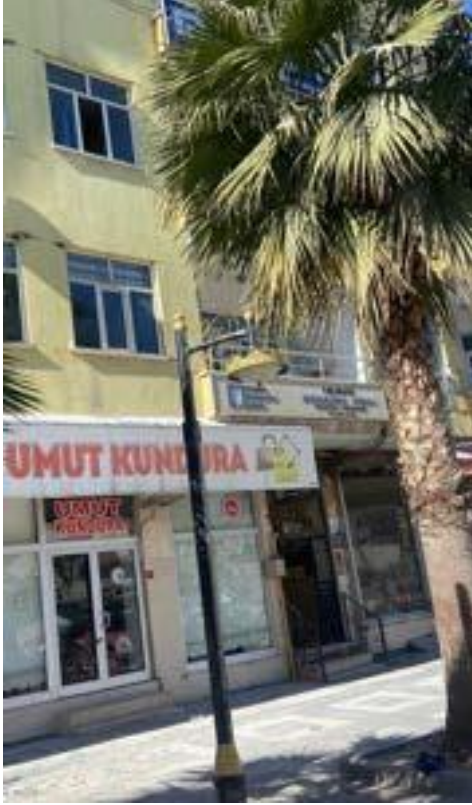
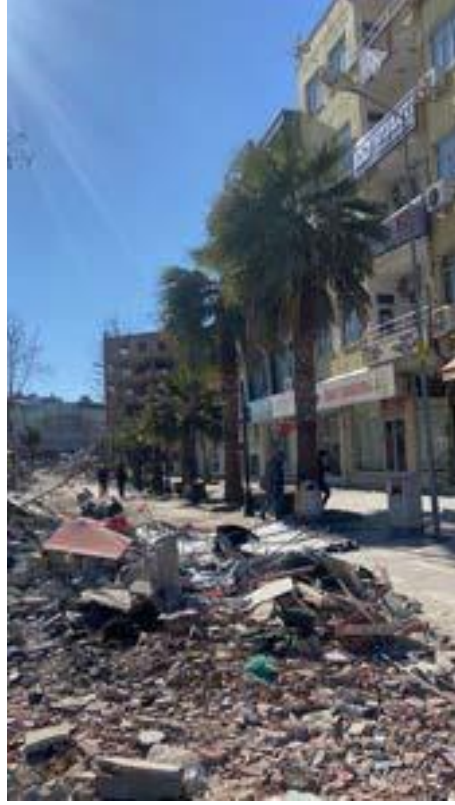
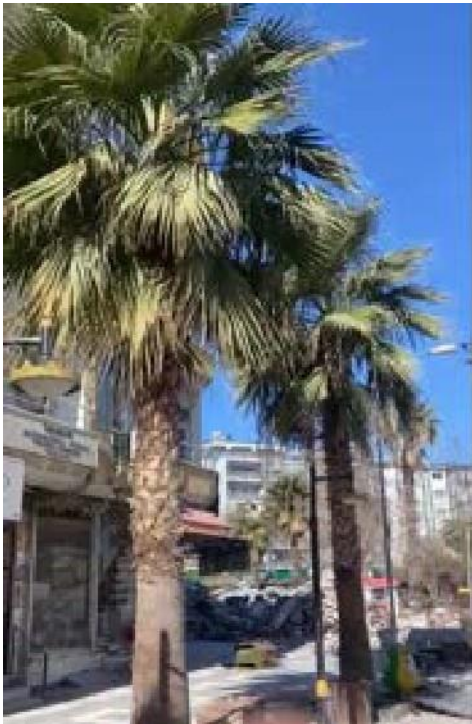
The building where the Adıyaman Representative Office of the Chamber of Architects is located

Structural damages are observed in the building where the Adıyaman Representative Office of the Chamber of Architects operates. The building, which is thought to be heavily damaged, could not be examined since no damage assessment was carried out.

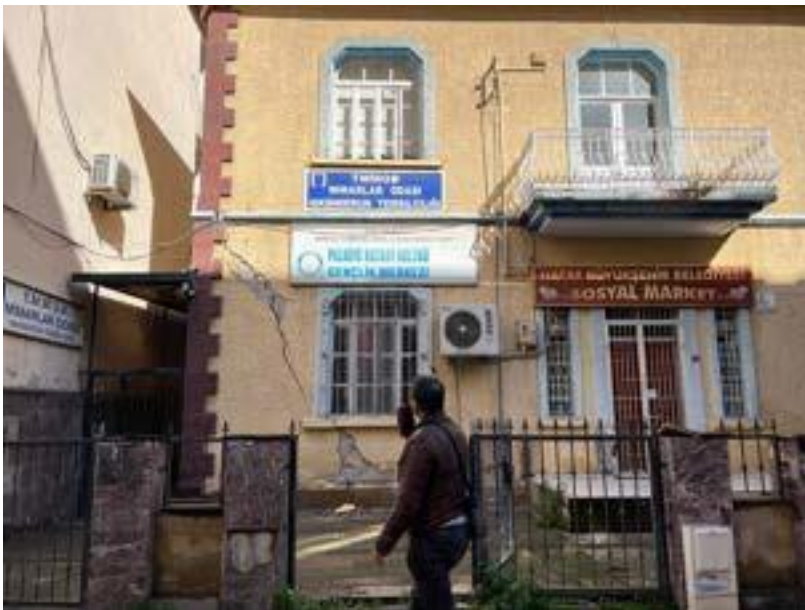
Structural damage was observed in the Chamber of Architects Iskenderun Representative Office building, but the building could not be examined since no damage assessment was made. There is also a need for re-evaluation after the earthquake in Hatay on 20 February 2023.
